# Home Inspection Report

Prepared for: Les Problems  
1234 Rival Dog Lane  
Lake Hood, WA 98123

Inspected by:  
Robert Burton & Fred Grant  
North Starr Inspections, Inc

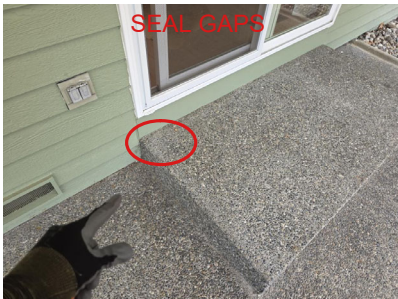
3. ☐☐☒☐ Steps/Stoops: Concrete: (SEAL GAPS) Recommend sealing any gaps along the steps or landing where it meets the foundation and siding as needed by a qualified professional.

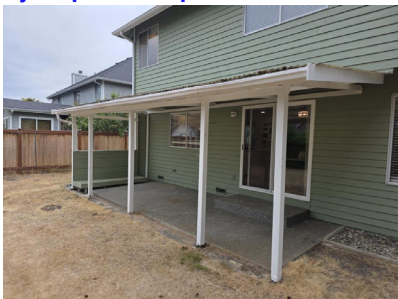
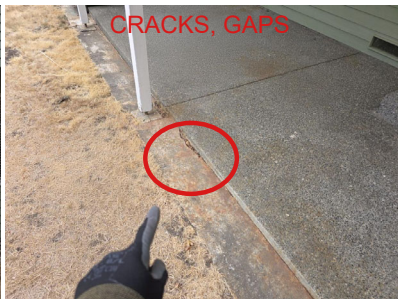
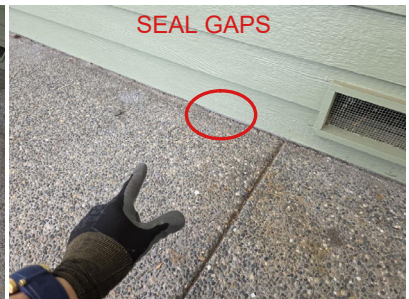
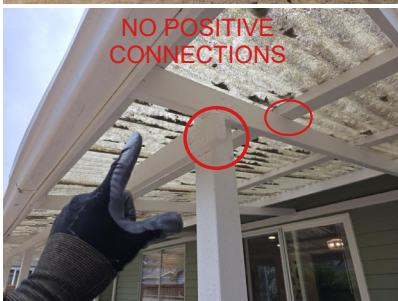
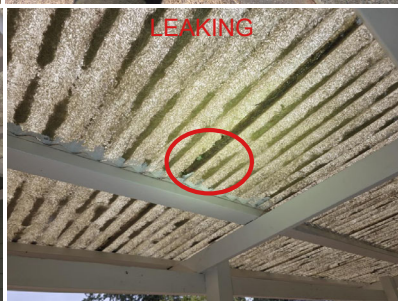
4. ☐☐☒☐ Covered Patio: Concrete: (COVERED CONCRETE PATIO NEEDS ATTENTION) Some examples of observations noted during the inspection include: 1) CRACKS ALONG EDGES, DETERIORATION. 2) GAPS BETWEEN PATIO & FOUNDATION. 3) COVERED ROOF MISSING POSITIVE CONNECTIONS POST TO BEAM. 4) DEBRIS COVERING PLASTIC ROOF. 5) ROOF LEAKS VISIBLE, ETC. | RECOMMENDATION: Further evaluation and repair as needed by a qualified professional.

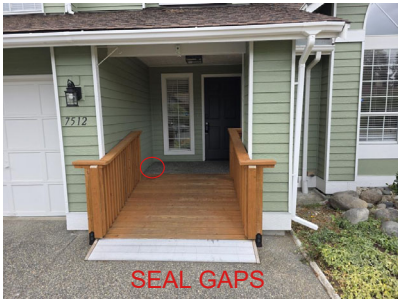
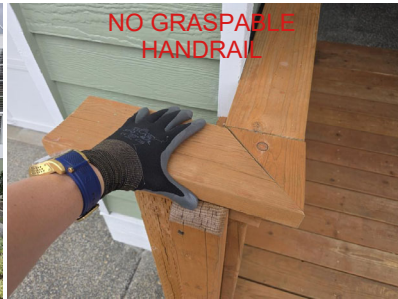
5. ☐☐☒☐ Porch: Wood, Metal Ramp: (SEAL GAPS BETWEEN PORCH & HOME) Recommend sealing any gaps as needed so no moisture can potentially rot the trim or siding and/or flow down the sides of the foundation by a qualified professional.  
(HANDRAIL NOT GRASPABLE) Recommend having a proper graspable handrail installed by a qualified professional as an upgrade to bring the railings up to present day standards.

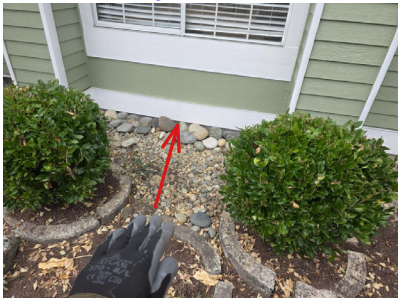
6. ☐☐☒☐ Grading: Negative slope: (GRADING MODIFICATION COULD BE BENEFECIAL) Minor modifications to the grading would be beneficial to improving water runoff away from the structure. A minimum slope of 1" per foot for every 4' AWAY from the structure will help, and more whenever possible is better.

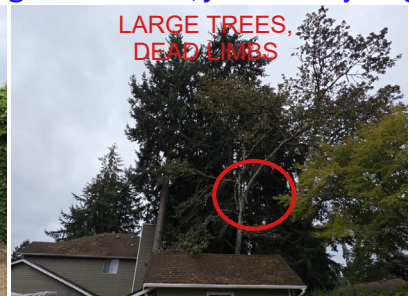
7. ☐☐☒☐ Yard & Environment: Large Trees, Ivy, Wood Fence: (WOOD FENCE: MOISTURE DAMAGE) We normally do not comment on wood fences as they are not a part of the structure, however, I did so as a courtesy. Recommend further evaluation and spot repair or replacement of any damaged components as and where needed by a qualified professional.  
(IVY GROWING ON FENCE, HOUSE, OR TREES) Recommend removing any ivy growing up a fence, on your house, or on trees as needed by a qualified professional to prevent damage.  
(LARGE TREES) Recommend making sure any trees on or overhanging the property are properly thinned so that they don't trap the wind in a wind storm, as they can pose a potential falling hazard. Also recommend keeping an eye out for any dead branches and removing them as needed. All maintenance should be done by qualified professionals. Trees need maintenance and care throughout their life, just like anything else.

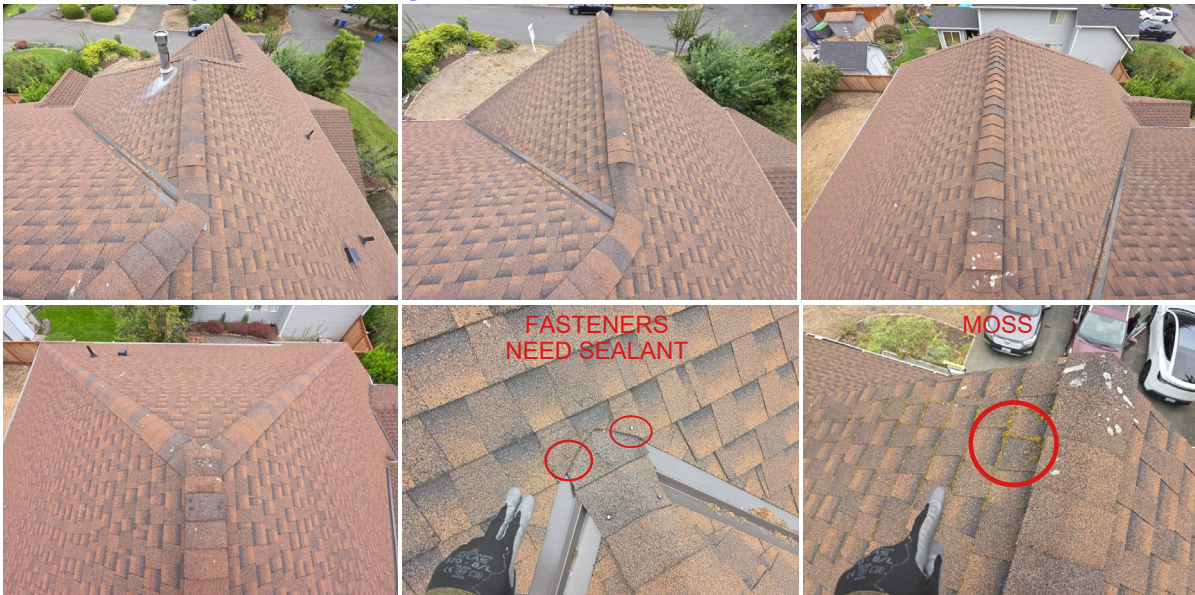
3. ☐ ☐ ☒ ☐ Material: Asphalt shingle: **(EXPOSED FASTENERS NEED SEALANT)** Recommend sealing all exposed fasteners with a high quality sealant as necessary and monitored. This is required per installation instructions for asphalt shingles by most manufacturers, and you can invalidate the warranty if you do not follow these guidelines.

**(MOSS GROWTH IN MULTIPLE SPOTS)** Recommend removing any moss as and where needed by a qualified professional who is in the business of dealing with these conditions and the specific roof material. Do NOT pressure wash your asphalt shingle roof.

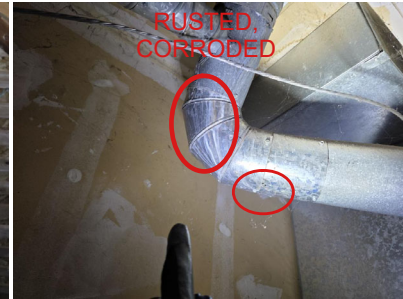
6. ☐☐☒☐ Flue Pipe Gas Pipe: **(SEVERELY RUSTED; HOLES & CORROSION)** We recommend replacing the entire flue pipe by a qualified professional as leaks may allow water to enter into the furnace or water heater.

10. ☐☐☒☐ Flue Pipe: Single wall and double walled. (RECOMMEND REPLACEMENT) See roof section/Flue Pipe for additional photos and info.

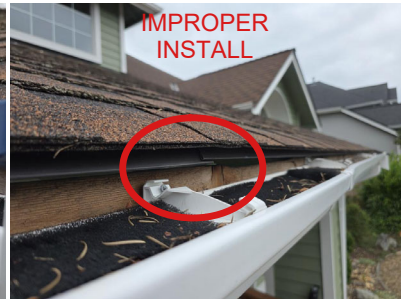
7. ☐☐☒☐ Flashing: Metal: **(DRIP EDGE POORLY INSTALLED: FLASHING INSPECTION)** We recommend further evaluation and repair/adjustment of the drip edge flashing placement & spacing above the gutters by a competent and licensed roofing or gutter professional as and where needed to restore functionality to the flashing and gutter system.

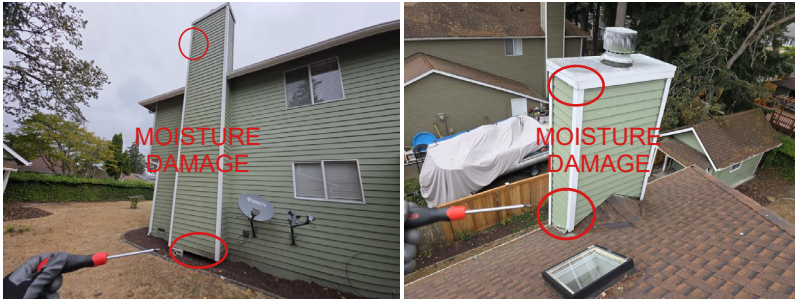
11. ☐☐☒☐ Chimney: Wood covered: (WOOD CHASE SIDING & TRIM ARE MOISTURE DAMAGED IN MULTIPLE SPOTS) Recommend further evaluation and replacement of any damaged boards as and where needed by a qualified professional. This may uncover hidden damage.

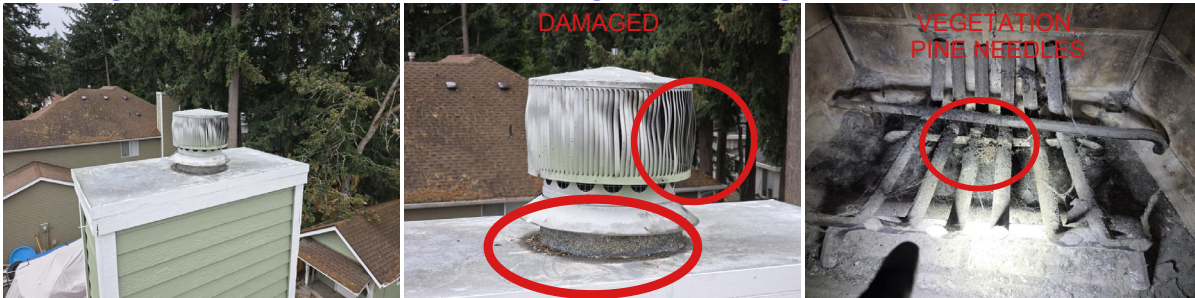
12. ☐☐☒☐ Flue/Flue Cap: Metal: (DAMAGED CHIMNEY CAP & STORM COLLAR) This can restrict exhaust draft and allow moisture or pests into the flue. The storm collar installation and seal also appear to be damaged and may be prone to leaking. Recommend further evaluation and repair or replacement as needed by a qualified chimney or roofing professional to ensure proper drafting and a watertight seal.

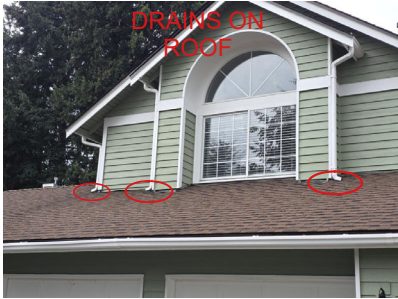
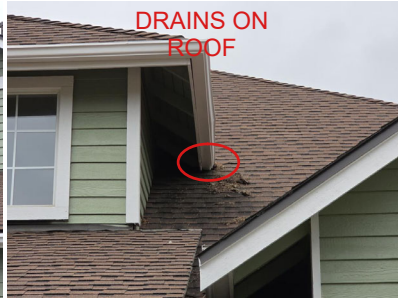
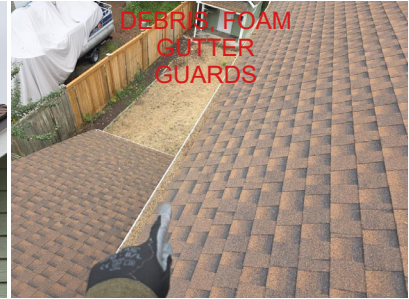
16. ☐☐☒ Gutters: Plastic: (GUTTERS & MULTIPLE DOWNSPOUTS DRAIN ONTO LOWER ROOF: WILL WEAR OUT THESE SECTIONS FASTER THAN REST) Recommend capping gutter ends and/or running downspouts along the roof line so it drains directly into a lower gutter system below it as and where needed by a qualified professional. (FOAM GUTTER GUARDS ARE FULL OF DEBRIS & REQUIRE ONGOING MAINTENANCE) The porous foam frequently traps roof granules and fine debris and eventually clogs, causing water to overflow. Recommend regular monitoring and regular removal/cleaning of the foam inserts to ensure proper gutter drainage by a qualified professional.

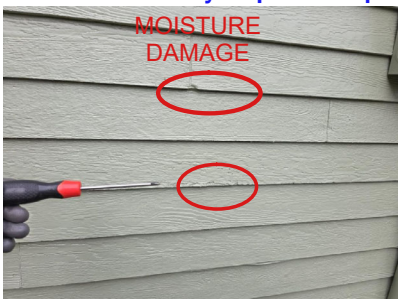
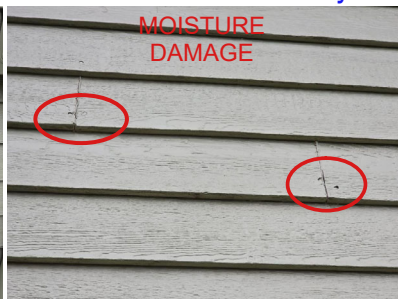
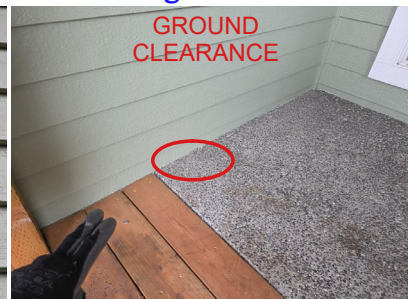
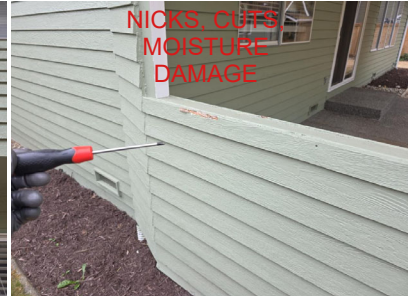
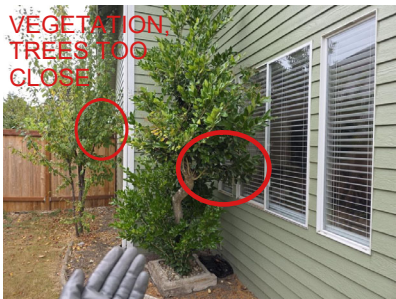
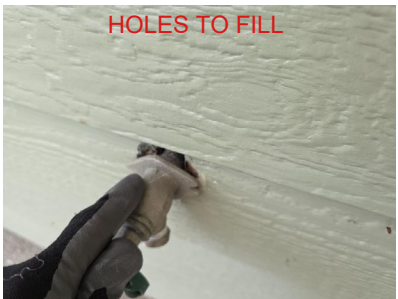
1. ☐☐☒ Siding Type: Composite Materials: (SIDING NEEDS ATTENTION) Some examples of observations noted during the inspection include: 1) LOCALIZED MOISTURE DAMAGE: PUFFING, SWELLING, DETERIORATION. 2) GROUND CLEARANCE TO HARDSCAPES NOT SUFFICIENT. 3) SIDING OVERHANG WOOD NOT PAINTED. 4) GAPS BETWEEN JOINTS. 5) NICKS, CUTS WITH DETERIORATED & MOISTURE DAMAGED SECTIONS. 6) VEGETATION & TREES TOO CLOSE TO SIDING. 7) SIDING HOLES TO FILL AROUND PIPES, FASTENER HOLES, ETC. | RECOMMENDATION: Further evaluation, repair, and/or replacement of siding and sections as and where needed by a qualified professional. NOTE: There may be hidden damage.

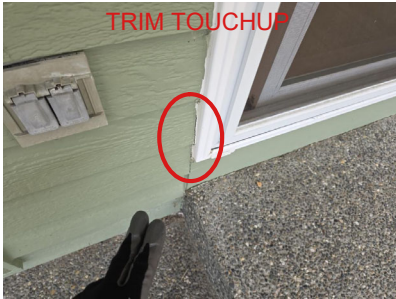
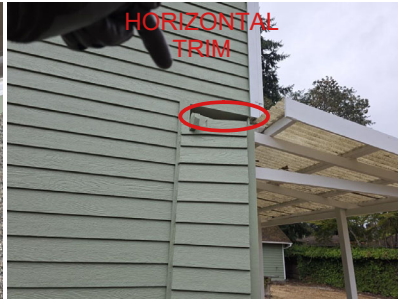
2. ☐ ☐ ☒ ☐ Trim: Wood: (TRIM NEEDS UPDATED SEALANT & PAINT IN SPOTS) Recommend applying a good quality paint and sealant as and where needed by a qualified professional. (HORIZONTAL TRIM) needs to be maintained more frequently than other styles. Recommend install installing metal flashing to protect the trim by a qualified professional.

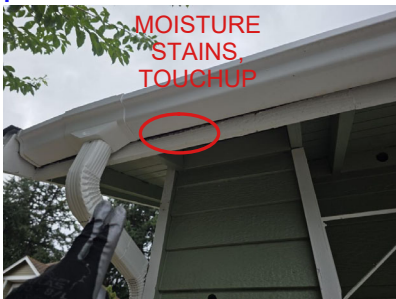
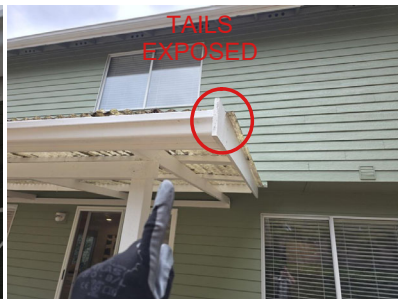
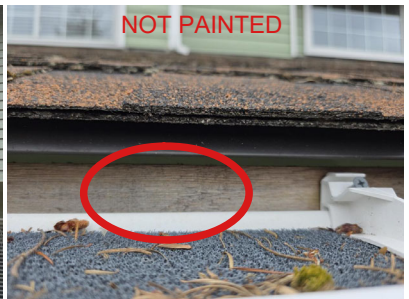
3. ☐ ☐ ☒ ☐ Fascia: Wood: (FASCIA NEEDS GENERAL MAINTENANCE) Some examples of observations include: 1) MOISTURE STAINS BEHIND GUTTERS. 2) EXPOSED SECTIONS NEED TOUCHUP. 3) COMPLETELY UNPAINTED SECTIONS, ETC. | RECOMMENDATION: Further evaluation and repair as and where needed by a qualified professional.

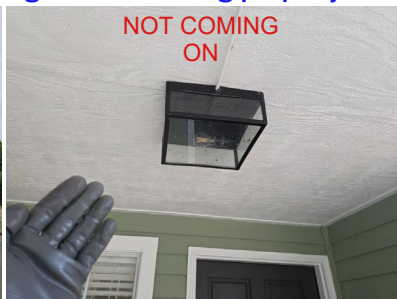
7. ☐☐☒☐ Exterior Lighting: Surface mount: (ONE OR MORE LIGHTS NOT COMING ON WITH CONTROLS: MAY BE CONTROLLED BY A PHOTOCELL OR BURNED OUT BULB) Recommend that these fixtures all be checked before closing to make sure the lights are working properly as and where needed by a qualified professional.

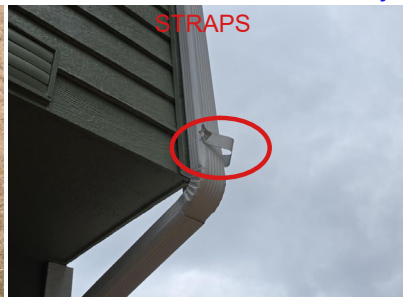
10. ☐☐☒☐ Downspouts: Aluminum: (ONE OR MORE DOWNSPOUTS DRAIN NEAR THE HOME, MISSING ELBOWS) Recommend installing elbows and adding leaders so as to direct water at least 6 feet away from the foundation wherever possible. (DOWNSPOUT STRAPS MISSING, DAMAGED, OR NOT SECURELY ATTACHED) Recommend properly attaching the downspouts securely to the home as and where needed by a qualified professional.

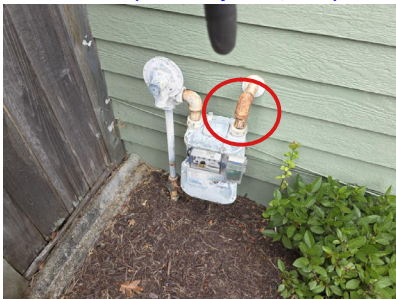
13. ☐ ☐ ☒ ☐ Gas Meter: Exterior Left: **(PAINT RUSTED FUEL LINES)** Recommend removing any rust and painting with rust inhibitive paint as/where needed by a qualified professional. This should include all gas fixtures and areas of the home (crawspace, etc).

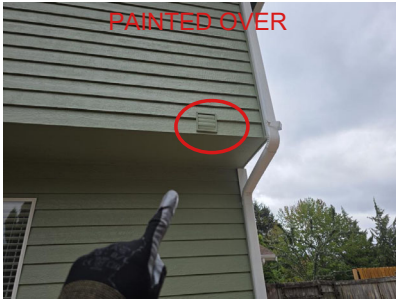
16. ☐☐☒☐ Side Vent: Plastic, Metal: (FLAPPER VENTS SHOULD NOT BE PAINTED OVER: CAN BECOME FUSED OR DECREASE FUNCTIONALITY) Recommend repair or replacement as and where needed by a qualified professional.

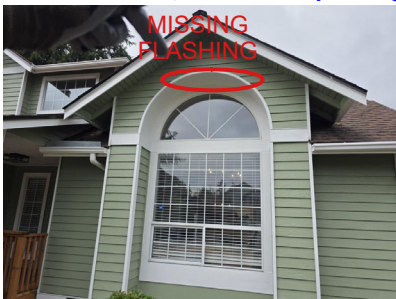
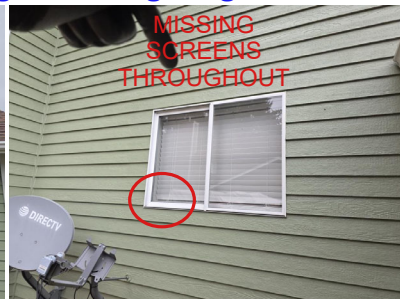
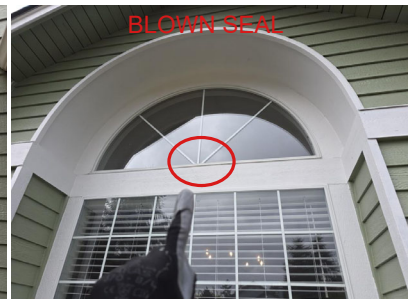
17. ☐☐☒☐ Windows Aluminum: (ONE OR MORE WINDOWS ARE MISSING FLASHING) Recommend installing flashing and sealing with a good quality sealant by a qualified professional and maintaining to prevent moisture damage. (MOST OF THE WINDOWS ARE MISSING SCREENS) Recommend installing window screens as and where needed to prevent insects or pests from entering the home when the windows are open. (ONE OR MORE WINDOWS APPEAR TO HAVE BREACHED SEALS) This is a failure of the seal between the two pieces of glass and is more of a cosmetic consideration than a functional one as it does not greatly affect the thermal insulation value of the window unit. There is no simple fix for this condition and cleaning the "fog" or condensation, short of replacing the entire glazing unit.

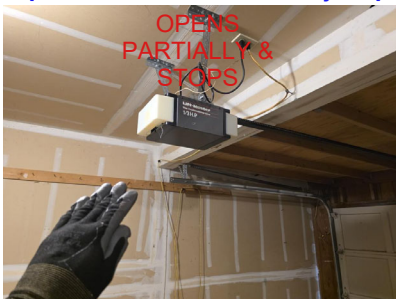
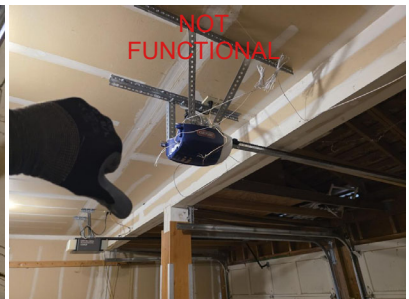
4. ☐ ☐ ☒ ☐ Door Opener: Lift Master, Genie: (GARAGE DOOR OPENERS ARE NOT FUNCTIONAL) One of the garage door openers was not responsive to any controls. The other unit had a hammer inserted in the track but would still only partially open and stop even after removing the hammer. Recommend further evaluation and repair or replacement as needed by a qualified garage door professional.

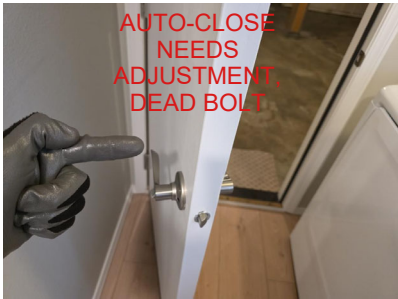
6. ☐☐☒☐ Occupant Door: Wood: (DOOR DOESN'T AUTO-CLOSE & MISSING DEAD BOLT) We recommend adjusting the hinges for the door to FULLY auto-close properly & installing a dead bolt for added safety by a qualified professional.  
(THRESHOLD PLATE NOT SUPPORTED) this can be a trip hazard and break down. Recommend adding support under the threshold as needed by a qualified professional.

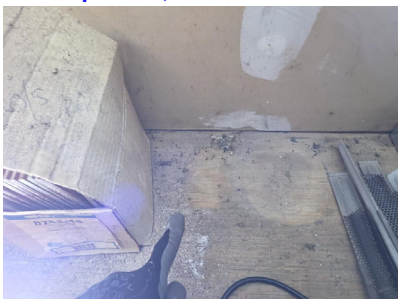
10. ☐☐☒☐ Floor/Foundation: Poured slab: (EVIDENCED OF RODENT ACTIVITY: FECES) The first step in eliminating rodents from the house is to seal all possible openings. We recommend obtaining the advice and services of a competent, licensed Pest Control Operator.

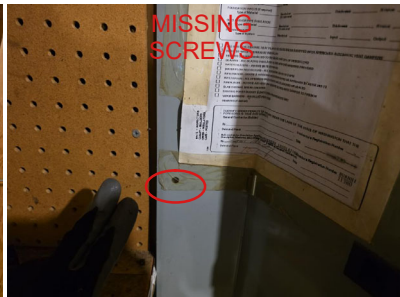
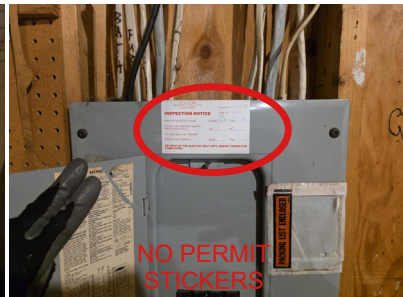
9. ☐ ☐ ☒ ☐ Manufacturer: Siemens: (MISSING OR IMPROPER COVER SCREWS) Recommend these be replaced as and where needed by a qualified professional.  
(MISSING PERMIT STICKERS: ONLY INSPECTION NOTICE PRESENT) Recommend inquiring with the seller and/or the city to ensure that all electrical permit inspections have been completed as required for the certificate of occupancy.

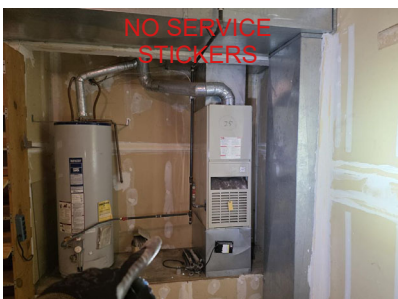
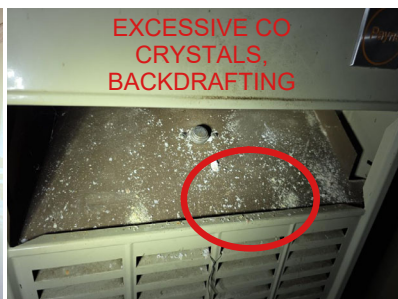
1. ☐ ☐ ☐ ☒ Heating System Operation: Appears functional, Recommend Immediate Servicing: **(RECOMMEND IMMEDIATE SERVICING: NO SERVICE STICKERS PRESENT, EVIDENCE OF BACKDRAFTING)** Some examples of observations noted at the time of inspection include: **1) EVIDENCE OF FLUE GAS SPILLAGE (WHITE MINERAL DEPOSITS, BACKDRAFTING) AND CORROSIVE CONDENSATE LEAKAGE WAS OBSERVED WITHIN AND BELOW THE FURNACE CABINET. 2) IN USE BEYOND STATED DESIGN LIFE, ETC. | RECOMMENDATION:** The central heating system should undergo a **FULL** service evaluation and system safety check-up by a qualified technician **TO INCLUDE** the ductwork and flue pipes immediately. We recommend that you look online for a reputable HVAC company, as any potential CO spillage or leakage into a Living Space is a concern. **(FURNACE IN USE BEYOND STATED DESIGN LIFE)** The furnace was manufactured in 1990 and is operating well beyond its typical 15 to 20-year design life. Units of this age are prone to sudden mechanical failure and hidden heat exchanger cracks. Recommend budgeting for system replacement and having a qualified HVAC contractor fully evaluate the unit for safety prior to the close of escrow.

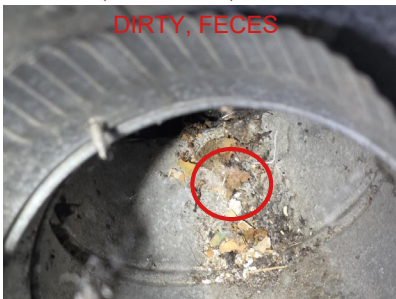
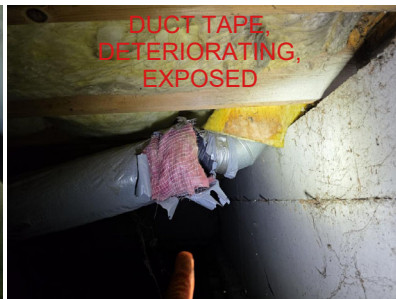
9. ☐☐☒ Distribution: Metal & Insulated Flex Duct: (RODENT ACTIVITY VISIBLE, COMPROMISED DUCTWORK, DIRTY: EVAL & REMEDIATE) Recommend further evaluation, replacement and remediation as needed by a qualified crawlspace & HVAC professional. We recommend that all rodent infested or damaged duct work be replaced as and where needed by a qualified professional, as well as ensuring that ALL the duct work in the home is cleaned, sanitized, and free of any rodent feces or urine.

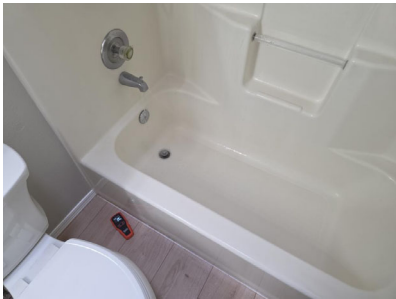
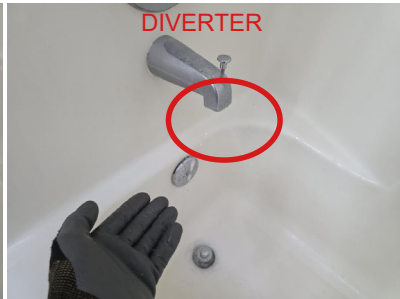
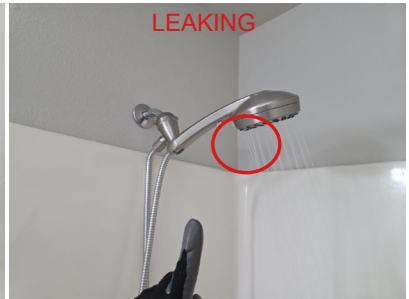
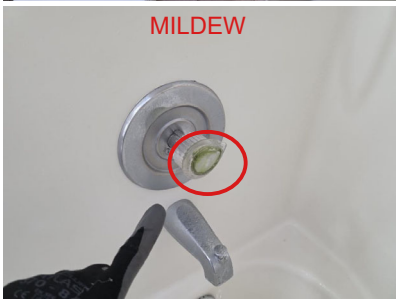
Some examples of observations noted during the inspection include: 1) SHOWER DIVERTER IS NOT DIVERTING FULLY. 2) SHOWER HEAD IS LEAKING. 3) MILDEW STAINS BEHIND HANDLE, ETC. | RECOMMENDATION: Further evaluation and repair or replacement of components as needed by a qualified professional. There may be hidden damage.

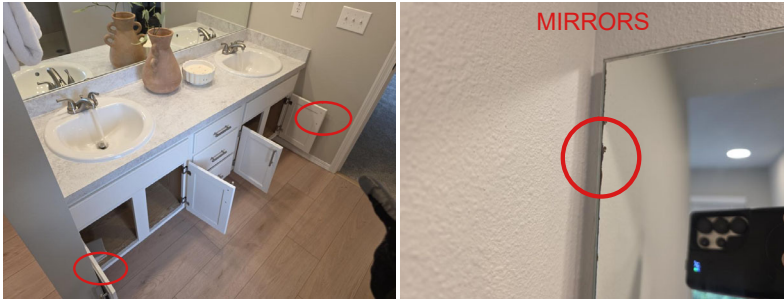
31. ☐☐☒☐ Counter/Cabinet: Laminate & Wood: (CABINET DOOR HITS SOMETHING) Recommend adding a silicone bumper to help reduce or prevent damage to the walls or cabinets. (MIRRORS ARE DETERIORATING) You may want to eventually replace or upgrade them as you feel the need to do so.

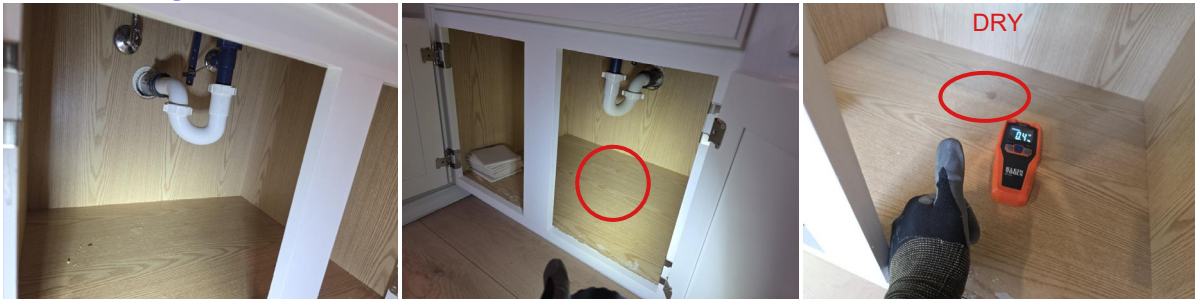
33. ☐☐☒☐ Fixtures/Traps: Fixtures with a PVC trap: (SIGNS OF A PAST OR INTERMITTENT LEAK: CABINETS SHOW MOISTURE STAINS, DRY AT INSPECTION) Recommend monitoring this area over time for visible leaks or moisture and consulting with a licensed plumber for further evaluation and repair as/if needed. There may be hidden damage.

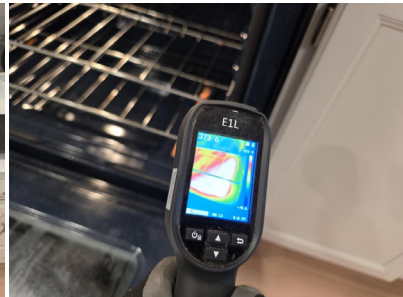
1. ☐☐☒☐ Cooking Appliances: Gas Cooktop & Oven: (NO ANTI-TIP DEVICE: SAFETY HAZARD FOR SMALL CHILDREN & ELDERLY) Recommend installing this to bring the range/cook top up to present day safety standards.

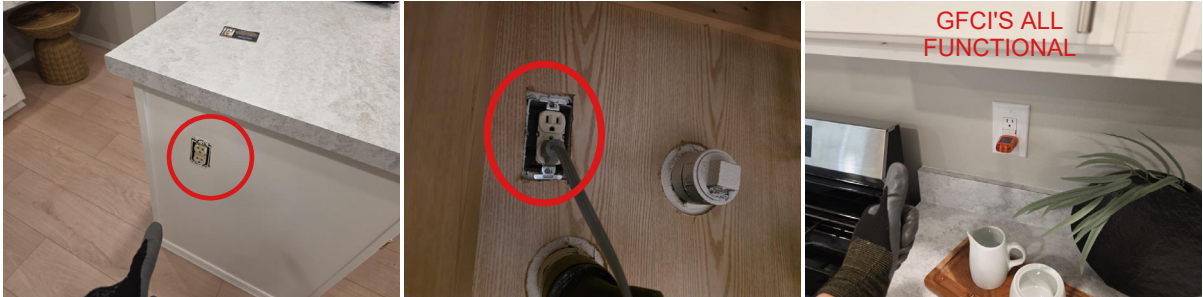
8. ☐☐☒☐ Electrical: 120 VAC GFCI: (MISSING OR DAMAGED COVER PLATE) Recommend replacing any damaged or missing cover plates as and where needed by a qualified electrician.

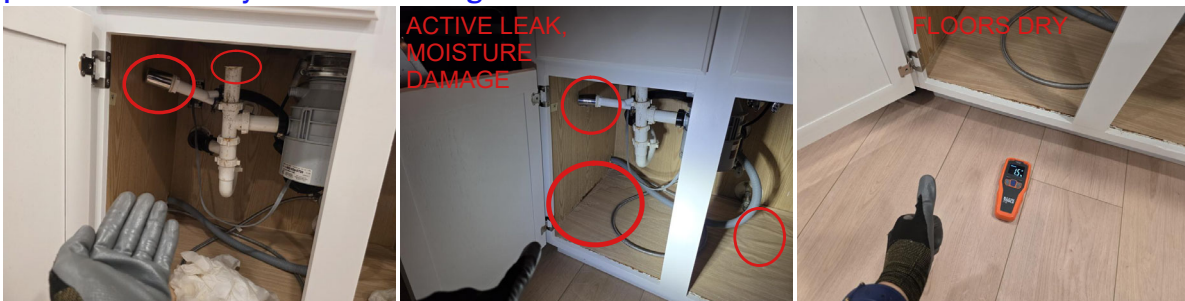
9. ☐☐☒☐ Plumbing/Fixtures: Fixtures with a PVC trap: (PLUMBING FIXTURES & AIR GAP NEED ATTENTION: IMPROPER INSTALL & OPEN DRAIN LINES) Some examples of observations noted include: 1) DRAIN LINES ARE IMPROPERLY INSTALLED, ABANDONED, AND OPEN. 2) SIGNS OF PAST LEAK & MOISTURE DAMAGE. 3) DRAIN LINES ACTIVELY LEAKING THROUGH IMPROPER INSTALLED AIR GAP, ETC. | RECOMMENDATION: Further evaluation and repair, adjustment, or replacement as needed by a licensed and COMPETENT plumber. There may be hidden damage.

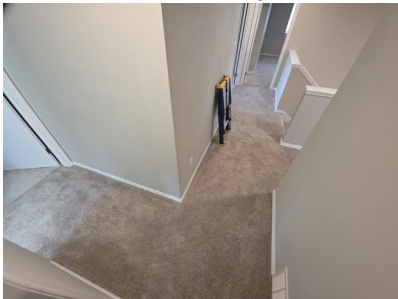
32. ☒☐☐☐ Floor: Carpet: (FLOOR SQUEAKS & DEFLECTION: NOT INDICATIVE OF STRUCTURAL WEAKNESS) In most cases these can be eliminated with additional mechanical fastening (screwing) of the subfloor to the floor joists. The repairs are easily performed in conjunction with floor covering replacement.

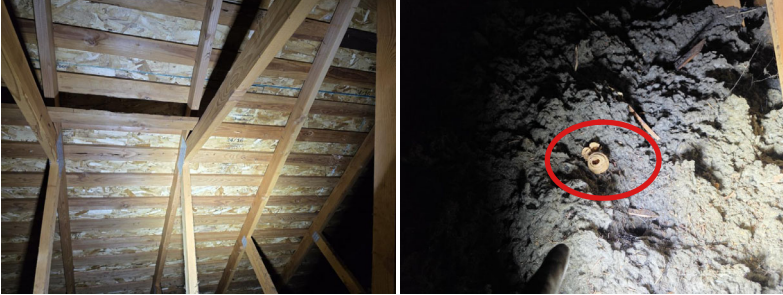
4. ☐☐☒☐ Sheathing: OSB over Skip Sheathing: (BEE OR WASP NEST) We recommend removal and/or treatment by a professional pest control operator to reduce the risk of potential personal injury.

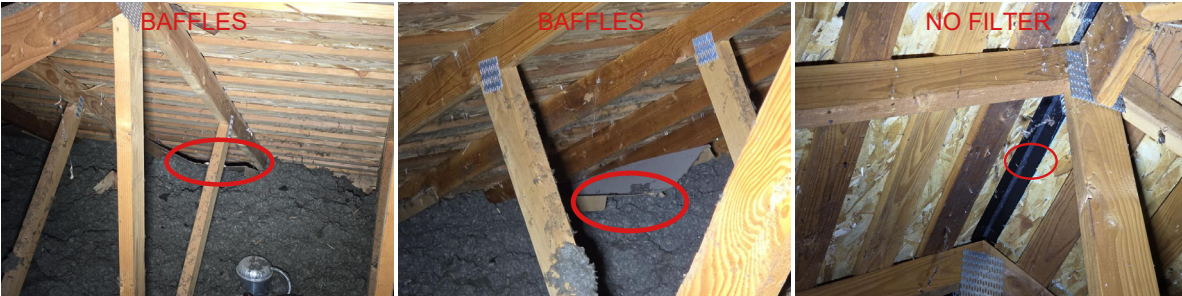
5. ☐☐☒☐ Ventilation: Ridge and soffit vents: (BAFFLES NEED ATTENTION: FALLING, INSULATION BLOCKING) Recommend replacing or reattaching falling baffle vents and removing any insulation blocking the soffit vents as and where needed by a qualified professional. (RIDGE VENT FILTER MISSING) Recommend installing a ridge vent filter a qualified roofing contractor to restore proper weather and pest protection.

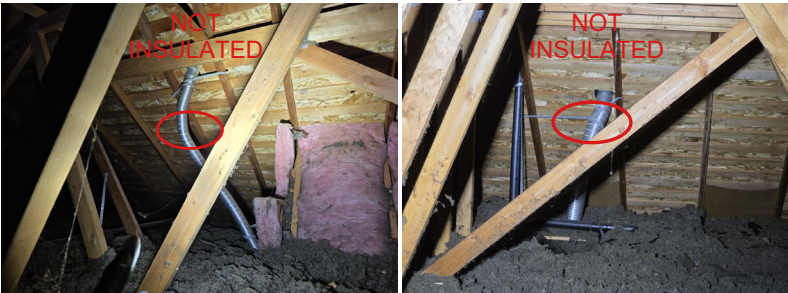
7. ☐☐☒☐ Fan & Exhaust Venting: Bathroom: (NOT INSULATED: CONDENSATION & MOISTURE LEAKAGE POTENTIAL) We recommend repair or replacement by a qualified professional as and where needed.

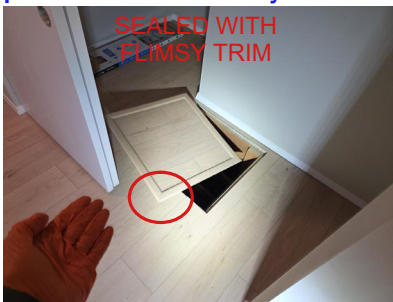
3. ☐☐☒☐ Access: Wood door: (RECOMMEND ADDING A HANDLE FOR EASY ACCESS) The access door is sealed with flimsy trim and is missing insulation underneath. Recommend installing a handle and insulating so as to not damage the trim ends.  
(LADDER IMPROPERLY INSTALLED: FALL HAZARD) Recommend repair or replacement by a qualified professional for safety as needed.

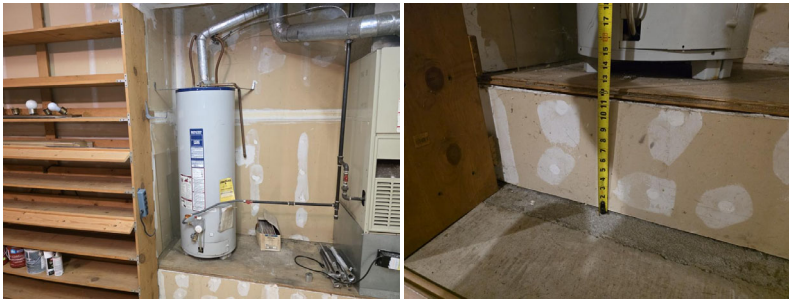
**(WATER HEATER OVER 25 YEARS OLD)** The age of the water heater is not a catch-all or direct determinant as to how long it will last, but it is a good gauge as to the remaining life you may have left. Anything over 10-15 years old is considered older by standards and towards the end of its useful and functional life. The water heater appeared to be functional however, we recommend playing it safe and planning on budgeting for a new water heater sometime in the future.

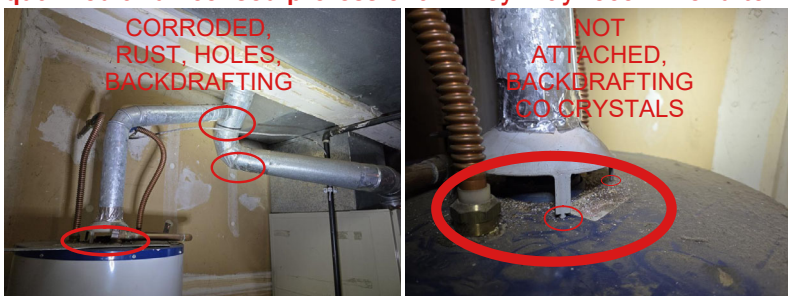
10. ☐☐☒ Flue Pipe: Single wall and double walled. **(WATER HEATER DUCTWORK NEEDS IMMEDIATE ATTENTION: POTENTIAL CO LEAKAGE)** Some examples of observations noted include: 1) TOP WATER DUCT IS NOT ATTACHED TO HEATER. 2) CO CRYSTALS INDICATE EVIDENCE OF BACKDRAFTING. 3) SHARED PIPE WITH FURNACE IS CORRODED, RUSTED & HAS CO CRYSTALS FALLING OUT OF HOLES, ETC. | **RECOMMENDATION:** Immediate servicing and replacement of the shared flue pipe and attaching the top water duct properly by a qualified and licensed professional. They may recommend to replace the entire unit.
