# Home Inspection Report

Prepared for: Les Problems  
1234 Rival Dog Lane  
Lake Hood, WA 98123

Inspected by:  
Robert Burton & Fred Grant  
North Starr Inspections, Inc

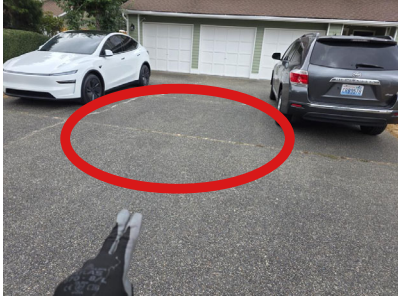
1. ☐☐☒☐ Driveway: Concrete: (TYPICAL CRACKS, MOSS) Recommend they be pressure washed and sealed to slow down moisture damage and monitored for larger cracks. This will also remove the moss.

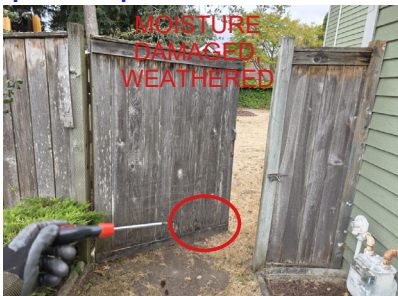
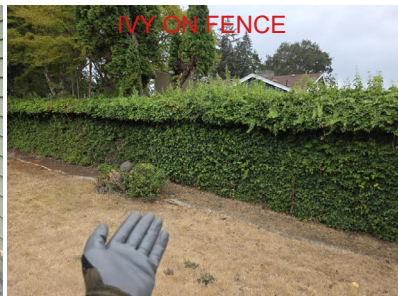
7. ☐☐☒☐ Yard & Environment: Large Trees, Ivy, Wood Fence: (WOOD FENCE: MOISTURE DAMAGE) We normally do not comment on wood fences as they are not a part of the structure, however, I did so as a courtesy. Recommend further evaluation and spot repair or replacement of any damaged components as and where needed by a qualified professional.  
(IVY GROWING ON FENCE, HOUSE, OR TREES) Recommend removing any ivy growing up a fence, on your house, or on trees as needed by a qualified professional to prevent damage.  
(LARGE TREES) Recommend making sure any trees on or overhanging the property are properly thinned so that they don't trap the wind in a wind storm, as they can pose a potential falling hazard. Also recommend keeping an eye out for any dead branches and removing them as needed. All maintenance should be done by qualified professionals. Trees need maintenance and care throughout their life, just like anything else.

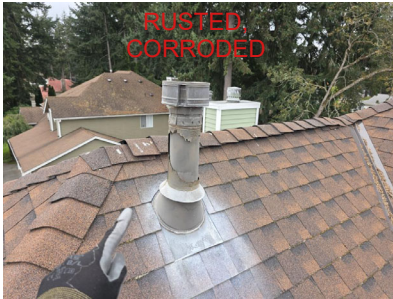
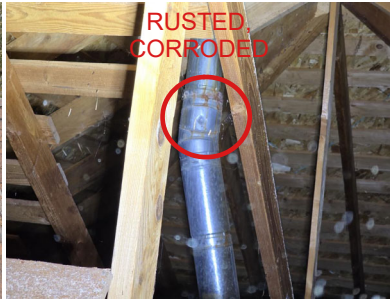
6. ☐☐☒☐ Flue Pipe Gas Pipe: **(SEVERELY RUSTED; HOLES & CORROSION)** We recommend replacing the entire flue pipe by a qualified professional as leaks may allow water to enter into the furnace or water heater.

10. ☐☐☒☐ Flue Pipe: Single wall and double walled. (RECOMMEND REPLACEMENT) See roof section/Flue Pipe for additional photos and info.

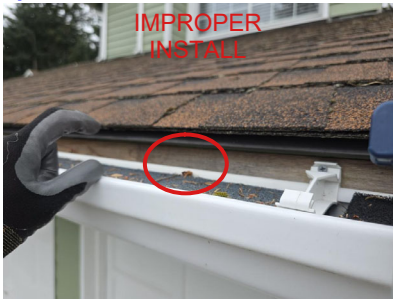
7. ☐☐☒☐ Flashing: Metal: **(DRIP EDGE POORLY INSTALLED: FLASHING INSPECTION)** We recommend further evaluation and repair/adjustment of the drip edge flashing placement & spacing above the gutters by a competent and licensed roofing or gutter professional as and where needed to restore functionality to the flashing and gutter system.

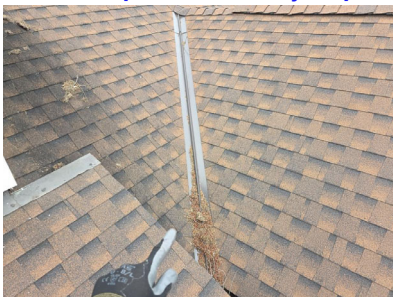
9. ☐☐☒☐ Valleys: Metal: **(DEBRIS)** Recommend removing all debris to ensure proper drainage and protect against moisture penetration by a qualified professional.

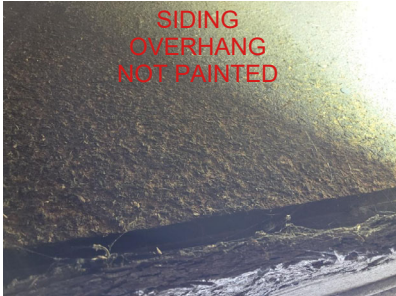
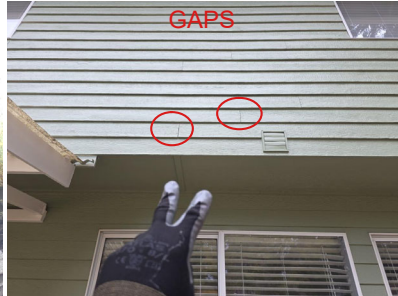
Siding Type: (continued)

1. ☐☐☒ Siding Type: Composite Materials: (SIDING NEEDS ATTENTION) Some examples of observations noted during the inspection include: 1) LOCALIZED MOISTURE DAMAGE: PUFFING, SWELLING, DETERIORATION. 2) GROUND CLEARANCE TO HARDSCAPES NOT SUFFICIENT. 3) SIDING OVERHANG WOOD NOT PAINTED. 4) GAPS BETWEEN JOINTS. 5) NICKS, CUTS WITH DETERIORATED & MOISTURE DAMAGED SECTIONS. 6) VEGETATION & TREES TOO CLOSE TO SIDING. 7) SIDING HOLES TO FILL AROUND PIPES, FASTENER HOLES, ETC. | RECOMMENDATION: Further evaluation, repair, and/or replacement of siding and sections as and where needed by a qualified professional. NOTE: There may be hidden damage.

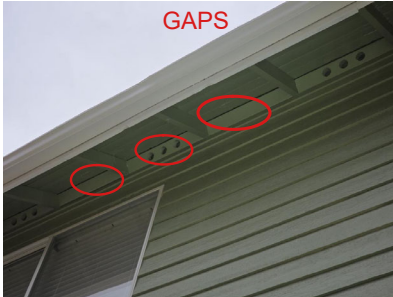
4. ☐☐☒☐ Soffits: Wood: (GAPS IN THE SOFFITS) Recommend these be sealed to prevent insects or other pests from accessing the attic space as and where needed by a qualified professional.

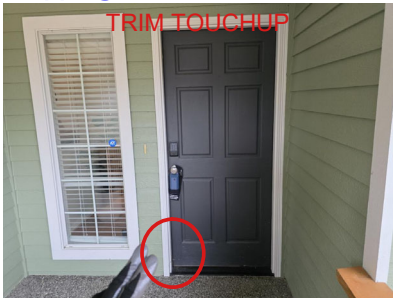
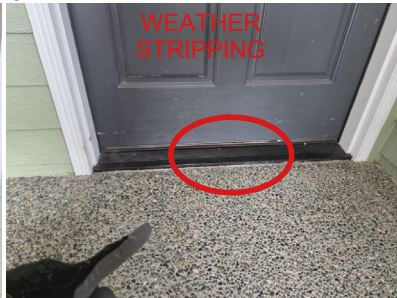
5. ☒☐☐☐ Door Bell: Hard wired
6. ☐☐☒☐ Entry Doors: Wood, Vinyl Slider: (DOOR & TRIM TOUCHUP) One or more of the exterior doors appears to be in need of some updated paint, stain, and/or sealant for added protection. This should ALWAYS include the door trim and threshold as and where needed by a qualified professional. (WEATHER STRIPPING IS MISSING OR DAMAGED) Recommend replacement and/or adding new weather stripping as and where needed by a qualified professional.

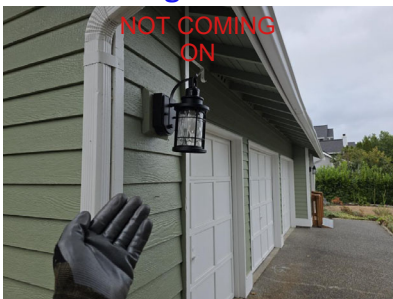
7. ☐☐☒☐ Exterior Lighting: Surface mount: (ONE OR MORE LIGHTS NOT COMING ON WITH CONTROLS: MAY BE CONTROLLED BY A PHOTOCELL OR BURNED OUT BULB) Recommend that these fixtures all be checked before closing to make sure the lights are working properly as and where needed by a qualified professional.

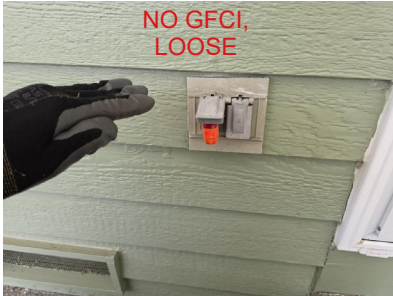
### Exterior Electric Outlets: (continued)

8. ☐☐☒☐ Exterior Electric Outlets: 120 VAC GFCI: (NO GFCI PROTECTION FOR ONE OR MORE OUTLETS, LOOSE FIXTURE) We recommend that GFCI protection be installed properly & securely in this area for an increased margin of safety by a competent, licensed electrician.

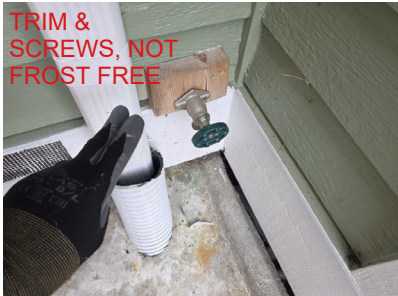
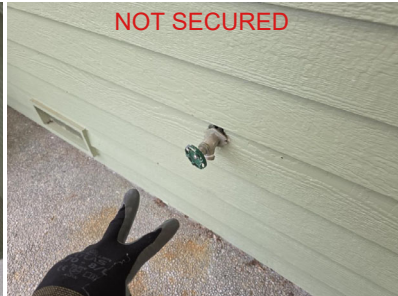
9. ☐☐☒☐ Hose Bibs: Rotary: (ONE OR MORE HOSE BIBS TRIM NEED UPDATED PAINT & SEALANT: INCLUDE ANY IMPROPERLY PENETRATED FASTENERS) Recommend painting and sealing as and where needed. (NOT SECURED OR ATTACHED PROPERLY) Recommend attaching and securing the hose bib to the side of the home in an approved manner as needed by a qualified professional. (ONE OR MORE HOSE BIBS ARE NOT FROST FREE: CAN POTENTIALLY FREEZE IN WINTER & CAUSE DAMAGE) Recommend installing frost-free hose bibs as and where needed by a qualified professional.

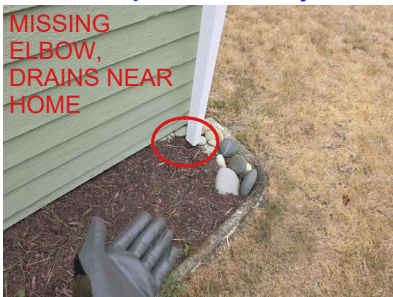
10. ☐☐☒☐ Downspouts: Aluminum: (ONE OR MORE DOWNSPOUTS DRAIN NEAR THE HOME, MISSING ELBOWS) Recommend installing elbows and adding leaders so as to direct water at least 6 feet away from the foundation wherever possible. (DOWNSPOUT STRAPS MISSING, DAMAGED, OR NOT SECURELY ATTACHED) Recommend properly attaching the downspouts securely to the home as and where needed by a qualified professional.

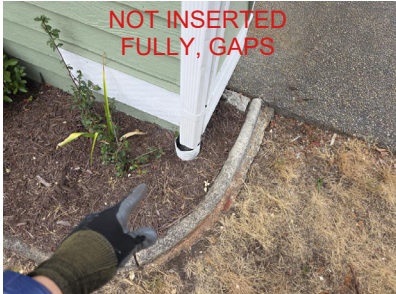
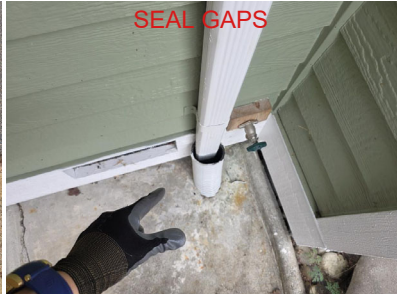
Leader/Extension: (continued)

11. ☐☐☒☐ Leader/Extension: Mixture of materials: (CAP, SEAL, OR INSERT FULLY) Recommend capping or sealing any exposed downspout drain lines or leaders to positively control water and prevent debris from entering pipe & extending the downspouts so they are inserted well into the underground drain lines as/if and where needed by a qualified professional.

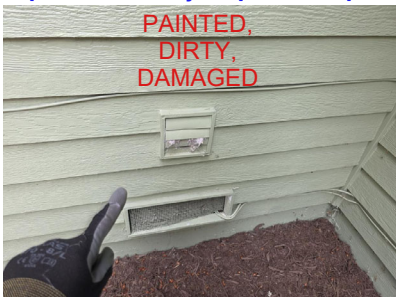
15. ☐ ☐ ☒ ☐ Dryer Vent: Plastic: **(DRYER VENT IS DIRTY, DAMAGED, AND FLAPPERS PAINTED OVER)** Recommend replacement by a qualified professional and cleaning the dryer vent regularly.

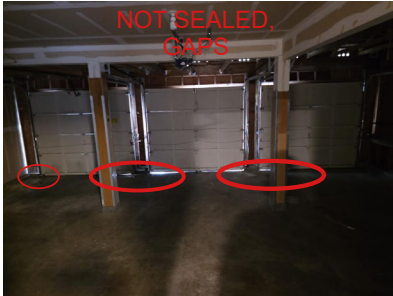
Garage Doors: (continued)

2. ☐☐☒☐ Garage Doors: Metal: (GARAGE DOOR ISN'T SEALED COMPLETELY TO FLOOR AND/OR FRAMING HAS VISIBLE GAPS) Recommend adjusting or replacing the seal to keep out unwanted pests as needed by a qualified professional.

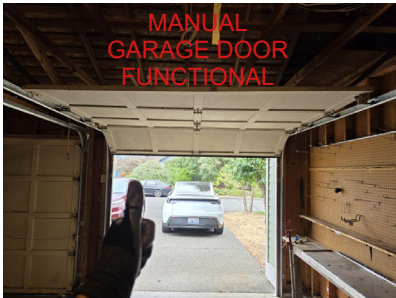
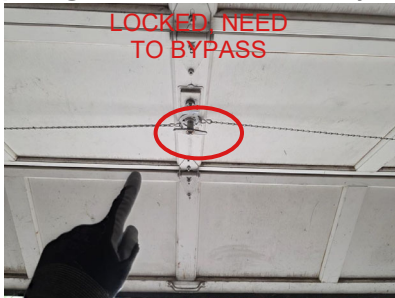
3. ☒ ☐ ☐ ☐ Door Operation: Mechanized & Manual: (MANUAL RELEASE IS LOCKED OR NOT FUNCTIONAL) The door can still be opened. Recommend inquiring with sellers for the key or removing as needed.

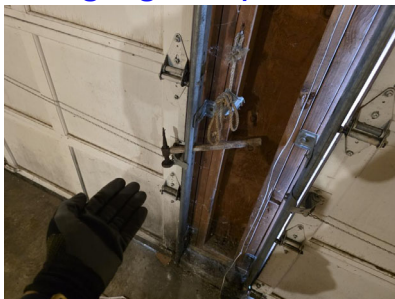
4. ☐ ☐ ☒ ☐ Door Opener: Lift Master, Genie: (GARAGE DOOR OPENERS ARE NOT FUNCTIONAL) One of the garage door openers was not responsive to any controls. The other unit had a hammer inserted in the track but would still only partially open and stop even after removing the hammer. Recommend further evaluation and repair or replacement as needed by a qualified garage door professional.

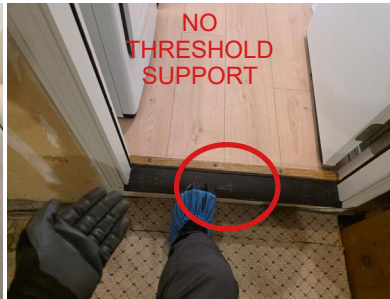
6. ☐☐☒☐ Occupant Door: Wood: (DOOR DOESN'T AUTO-CLOSE & MISSING DEAD BOLT) We recommend adjusting the hinges for the door to FULLY auto-close properly & installing a dead bolt for added safety by a qualified professional.  
(THRESHOLD PLATE NOT SUPPORTED) this can be a trip hazard and break down. Recommend adding support under the threshold as needed by a qualified professional.

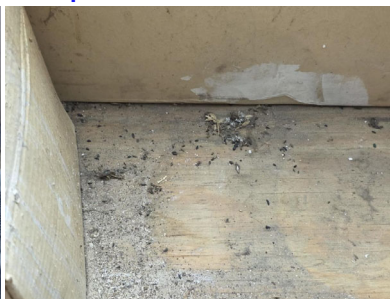
10. ☐☐☒☐ Floor/Foundation: Poured slab: (EVIDENCED OF RODENT ACTIVITY: FECES) The first step in eliminating rodents from the house is to seal all possible openings. We recommend obtaining the advice and services of a competent, licensed Pest Control Operator.

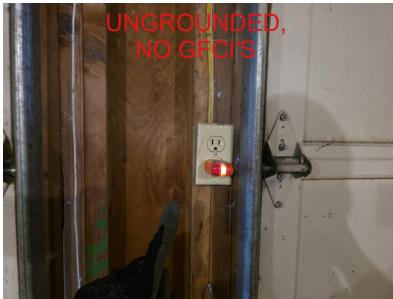
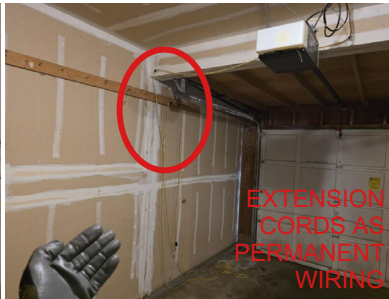
11. ☐☐☒☐ Electrical: 120 VAC: (EXTENSION CORDS USED AS PERMANANT WIRING) We recommend removal of all permanently installed extension cord wiring and replacement with appropriate wiring as and where needed by a qualified electrician.  
(UNGROUND, RECOMMEND GFCI) For maximum personal safety, all kitchen, bathroom, garage, and exterior receptacles should be upgraded with Ground Fault Interrupt protection by a licensed electrician.

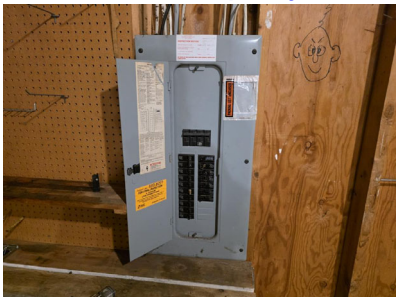
9. ☐ ☐ ☒ ☐ Manufacturer: Siemens: (MISSING OR IMPROPER COVER SCREWS) Recommend these be replaced as and where needed by a qualified professional.  
(MISSING PERMIT STICKERS: ONLY INSPECTION NOTICE PRESENT) Recommend inquiring with the seller and/or the city to ensure that all electrical permit inspections have been completed as required for the certificate of occupancy.

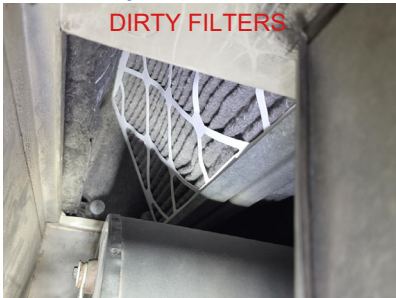
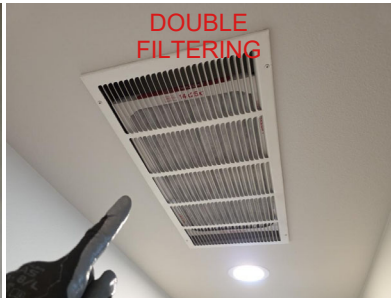
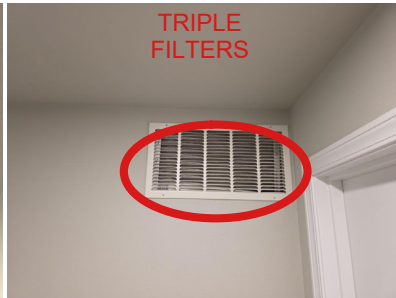
6. ☐☐☒ Filter: Disposable: (DIRTY FILTER & DOUBLE FILTERING AT MULTIPLE RETURN GRILLS) "Double filtering" severely restricts airflow and can overheat or damage the HVAC system. Recommend replacing the dirty furnace filter, completely removing the redundant return grille filters, and maintaining only a single filter location by a qualified HVAC professional.

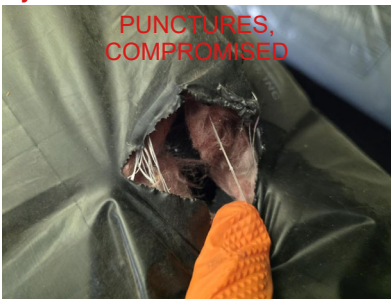
9. ☐☐☒ Distribution: Metal & Insulated Flex Duct: (RODENT ACTIVITY VISIBLE, COMPROMISED DUCTWORK, DIRTY: EVAL & REMEDIATE) Recommend further evaluation, replacement and remediation as needed by a qualified crawlspace & HVAC professional. We recommend that all rodent infested or damaged duct work be replaced as and where needed by a qualified professional, as well as ensuring that ALL the duct work in the home is cleaned, sanitized, and free of any rodent feces or urine.

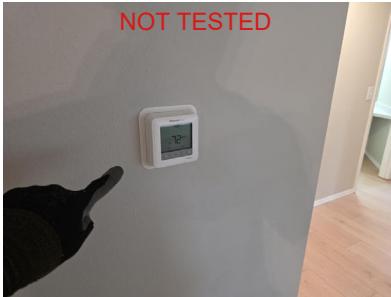
11. ☒☐☐☐ Thermostats: Programmable: (HEATING NOT TESTED: BACKDRAFTING, RODENTS) The heating system was not tested due to excessive CO crystals, compromised ductwork, and visible rodent activity within the ductwork and under multiple registers in the home. PLEASE SEE DISTRIBUTION SECTION.

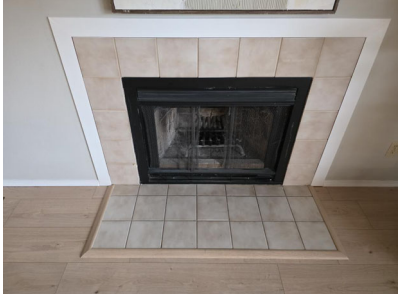
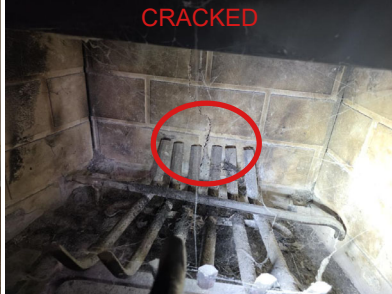
Fireplace Construction: (continued)

1. ☐☐☒☐ Fireplace Construction: Brick: (RECOMMEND SERVICING BEFORE FIRST TIME USE AS WE DO NOT TEST WOOD BURNING UNITS: CRACKED REFRACTORY PANEL) Recommend having the fireplace serviced by a qualified professional before using for the first time. This should also include checking the firebox material and the chimney flue, which is not part of the home inspection process and the Standards of Practice.

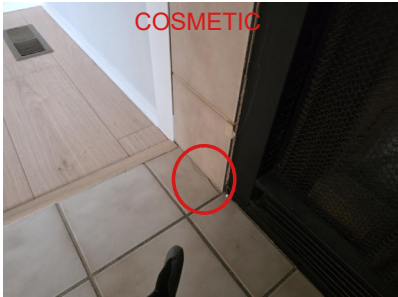
4. ☒ ☐ ☐ ☐ Hearth: Flush mounted: (HEARTH MATERIAL OR MORTAR HAS COSMETIC DAMAGE) We will always recommend repair for a better appearance, however, this would be considered optional.

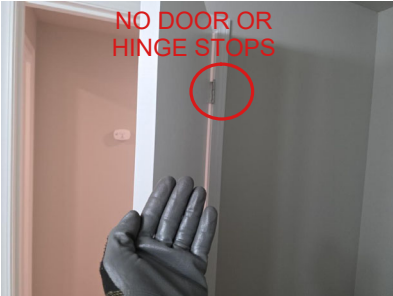
4. ☐ ☐ ☒ ☐ Doors: Wood: (MISSING DOOR/HINGE PIN STOPS: MOSTLY THROUGHOUT) Recommend installing these as and where needed by a qualified professional to help preserve the wall finish and doors.

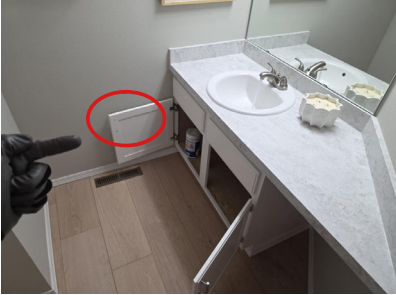
6. ☐☐☒☐ Counter/Cabinet: Laminate, Wood: (CABINET DOOR HITS SOMETHING) Recommend adding a silicone bumper to help reduce or prevent damage to the walls or cabinets.

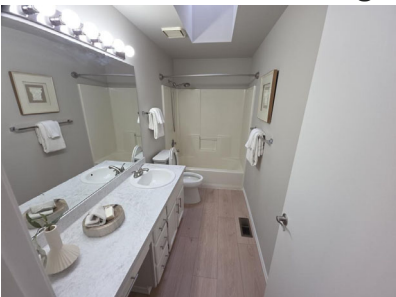
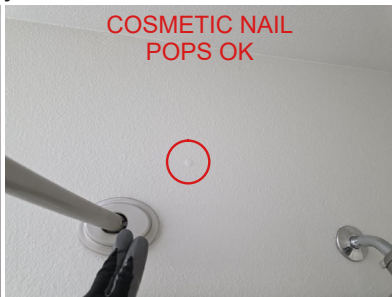
13. ☒☐☐☐ Walls: Drywall: (NAIL POPS, COSMETIC) Any protruding nails can be reset and the areas then prepped and refinished to restore the integrity of the surface as needed.

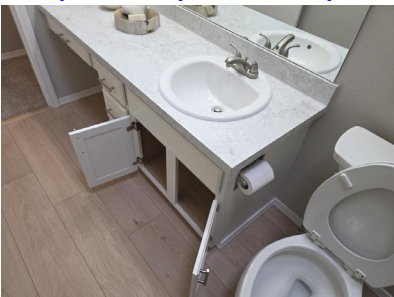
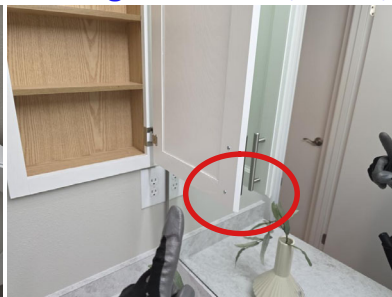
18. ☐ ☐ ☒ ☐ Counter/Cabinet: Laminate & Wood: (CABINET DOOR HITS SOMETHING) Recommend adding a silicone bumper to help reduce or prevent damage to the walls, mirror, or cabinets.

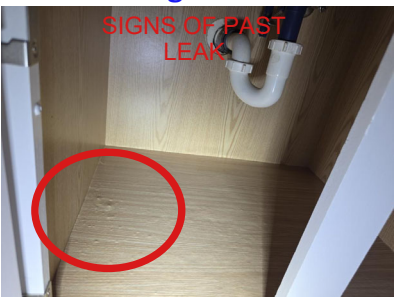
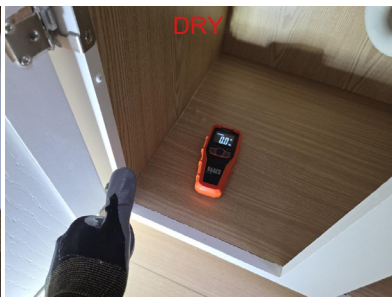
20. ☐ ☐ ☒ ☐ Fixtures/Traps: Fixtures with a PVC trap: (SIGNS OF A PAST OR INTERMITTENT LEAK: CABINETS SHOW MOISTURE DAMAGE) \*CABINETS WERE DRY\* Recommend monitoring this area over time for visible leaks or moisture and consulting with a licensed plumber for further evaluation and repair as/if needed. There may be hidden damage.

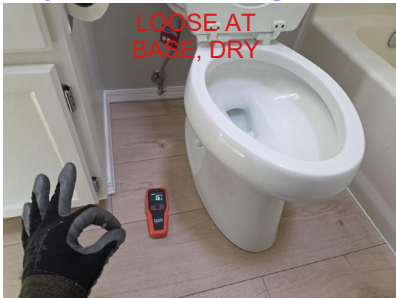
22. ☐☐☒☐ Toilets: Floor mounted: (TOILET LOOSE AT BASE: FLOORS DRY) We recommend further evaluation and repair as needed by replacing the wax ring and properly securing the toilet to the floor with flange bolts and applying silicone around the base by a qualified professional. Floors were dry at time of inspection. There may be hidden damage.

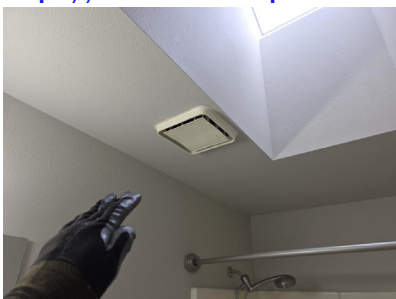
24. ☐☐☒☐ Ventilation: Electric ventilation fan: (BATHROOM FAN NOISY) Recommend repair or replacement as needed by a qualified professional. Here is a link for a couple of ways to try to fix it without replacing it.  
<https://removeandreplace.com/2017/03/10/noisy-bathroom-exhaust-fan-how-to-easily-fix-without-replacing/>

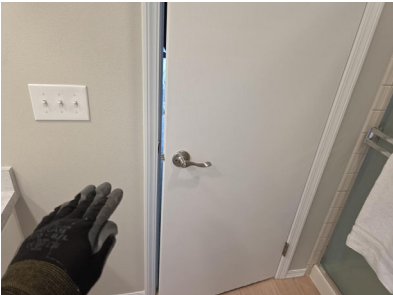
28. ☐ ☐ ☒ ☐ Doors: Wood: (DOES NOT LATCH PROPERLY) Recommend repair or adjustment as needed to restore full operation and smooth functionality by a qualified professional.

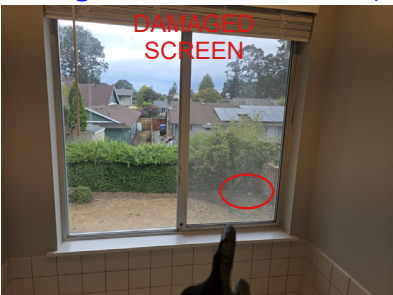
29. ☐ ☐ ☒ ☐ Windows: Aluminum: (ONE OR MORE SCREENS ARE DAMAGED) Recommend repairing and/or replacing damaged windows screens as/where needed to keep pests from entering whenever the windows are open.

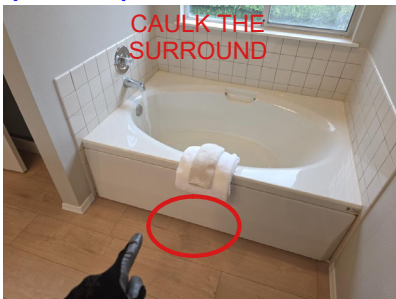
34. ☐☐☒☐ Tub/Surround: Fiberglass Tub & Surround: (CAULK, GROUT, OR SEAL THE SURROUND) We recommend inspecting and sealing any/all areas in and outside of the shower that might need sealant as needed by a qualified professional.

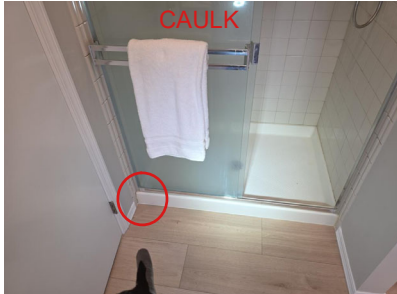
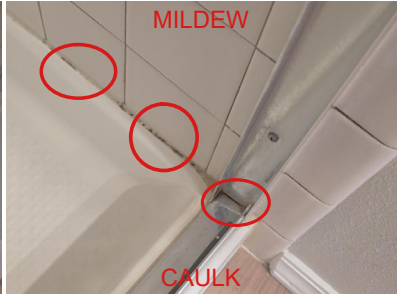
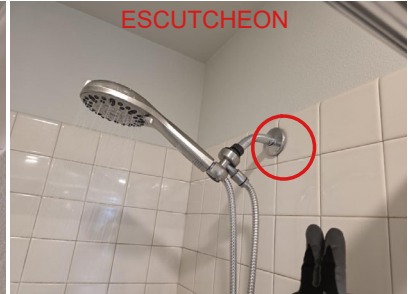
35. ☐☐☒☐ Shower/Surround: Fiberglass Pan & Tile Surround : (SURROUND NEEDS ATTENTION) Some examples of observations noted during the inspection include: 1) SURROUND NEEDS UPDATED CAULK & SEALANT IN SPOTS. 2) SHOWER ESCUTCHEON IS NOT SEALED. 3) MILDEW STAINS, ETC. | RECOMMENDATION: Further evaluation and repair as needed by a qualified professional.

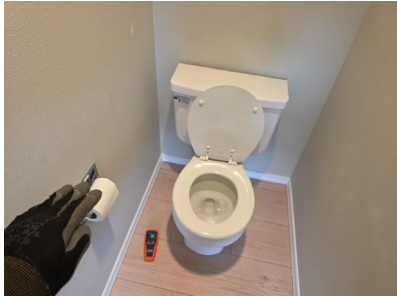
36. ☐☐☒☐ Toilets: Floor mounted: (NEEDS FLUSH KIT: WATER KEEPS RUNNING) Recommend further evaluation and repair or replacement of the flapper and/or complete flush kit by a qualified professional.

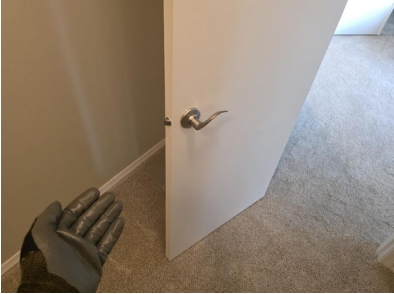
17. ☒ ☐ ☐ ☐ Closet: Walk In: (NOTES: MISSING EFFECTIVE DOOR STOPS) See doorstop notes in other sections.  
Recommend installing to protect walls and doors.

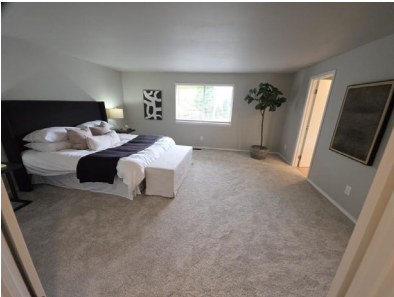
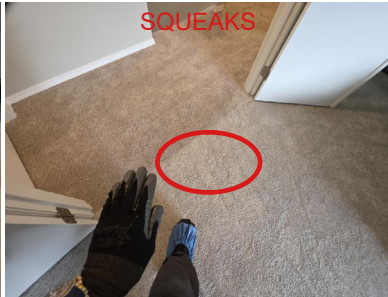
20. ☒ ☐ ☐ ☐ Floor: Carpet: (FLOOR SQUEAKS, DOES NOT APPEAR INDICATIVE OF STRUCTURAL WEAKNESS) Recommend repair as and where needed through additional mechanical fastening (screwing) of the subfloor to the floor joists by a qualified professional.

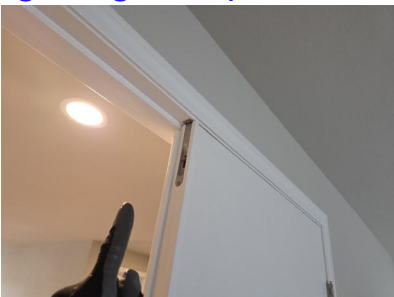
21. ☐ ☐ ☒ ☐ Doors: Wood, French Doors: (FRENCH DOOR TOP BOLTS, SPACE AT TOP ALLOWS RATTLING) Recommend tightening these up as needed with a silicone bumper by a qualified professional.

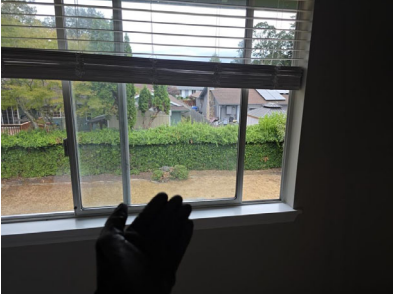
22. ☒ ☐ ☐ ☐ Windows: Aluminum: (NOTES: MISSING SCREENS) Mentioned in Exterior Window notes.

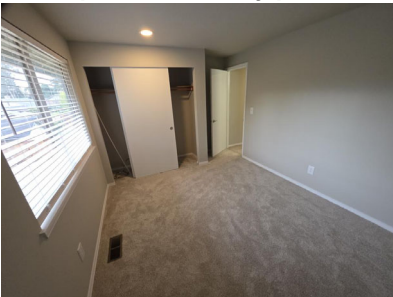
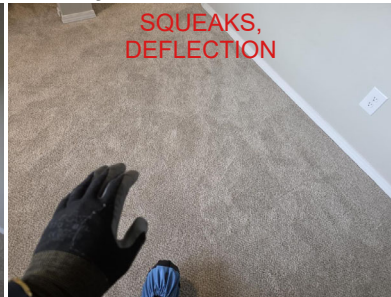
28. ☒ ☐ ☐ ☐ Floor: Carpet: (FLOOR SQUEAKS & DEFLECTION: NOT INDICATIVE OF STRUCTURAL WEAKNESS) In most cases these can be eliminated with additional mechanical fastening (screwing) of the subfloor to the floor joists. The repairs are easily performed in conjunction with floor covering replacement.

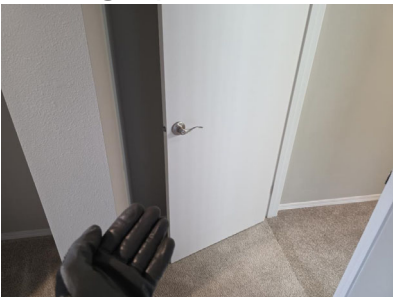
29. ☒ ☐ ☐ ☐ Doors: Wood: (NOTES: MISSING EFFECTIVE DOOR STOPS) See doorstop notes in other sections. Recommend installing to protect walls and doors.

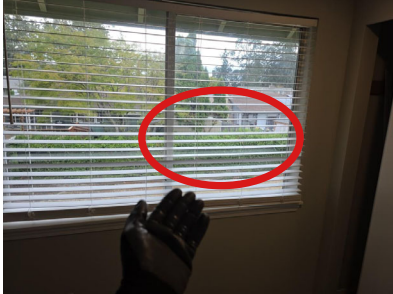
30. ☒☐☐☐ Windows: Aluminum: (NOTES: MISSING SCREENS) Mentioned in Exterior Window notes.

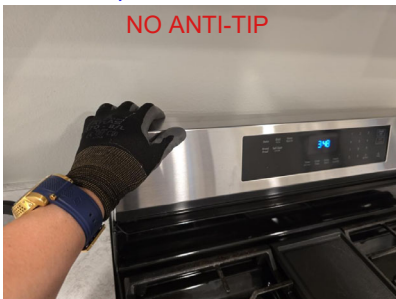
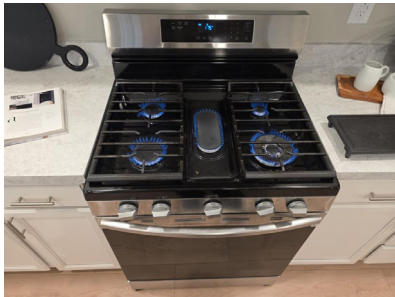
1. ☐☐☒☐ Cooking Appliances: Gas Cooktop & Oven: (NO ANTI-TIP DEVICE: SAFETY HAZARD FOR SMALL CHILDREN & ELDERLY) Recommend installing this to bring the range/cook top up to present day safety standards.

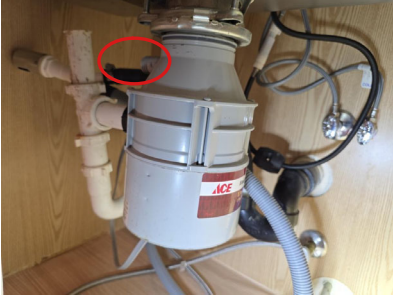
3. ☐☐☒☐ Disposal: Insinkerator: (MISSING CAP, OPEN PORT) The dishwasher inlet port on the side of the disposal is open and uncapped. We recommend a licensed and COMPETENT plumber install a proper cap over the open inlet port to prevent potential water damage.

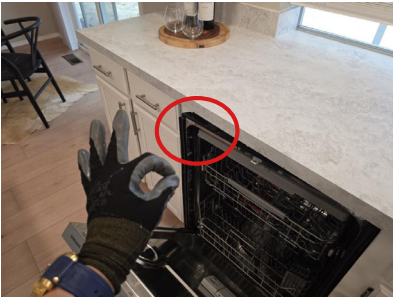
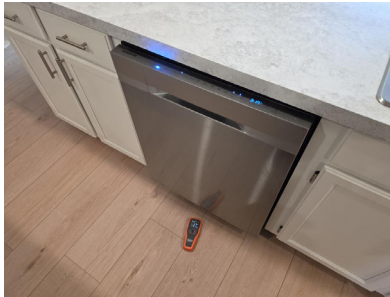
4. ☐☐☒☐ Dishwasher: Built-In: (NOT SECURED TO CABINETRY, LOOSE) Recommend attaching the unit properly according to manufacturer's instructions by a qualified professional.

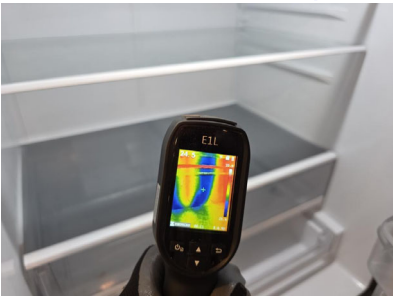
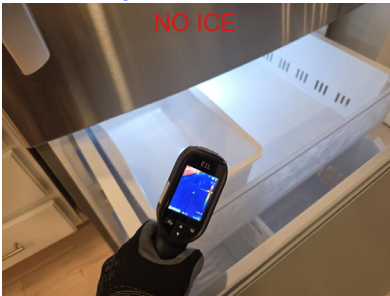
6. ☐☐☒☐ Refrigerator: Stacked Freezer/Frigrator: (NO ICE IN ICE MAKER: MAY BE TURNED OFF) Recommend checking this before closing and having the seller demonstrate functionality. If the unit still doesn't work, recommend further evaluation and repair as needed by a qualified professional.

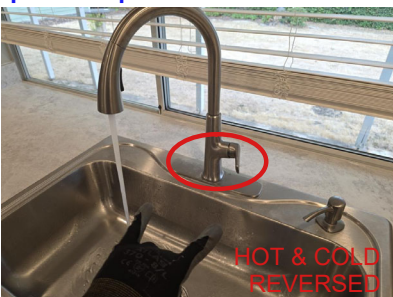
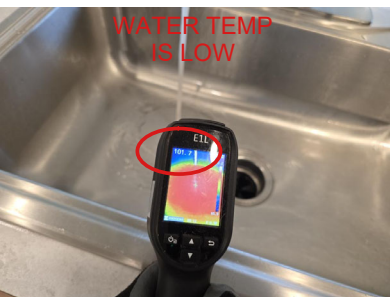
7. ☒☐☒☐ Sink: Stainless Steel 1 compartment: (HOT & COLD ARE REVERSED) Recommend switching the flex lines under the sink as needed by a qualified professional. (WATER TEMP IS LOW AT 101 DEGREES) Recommend servicing the water heater or replacing as needed by a qualified professional.

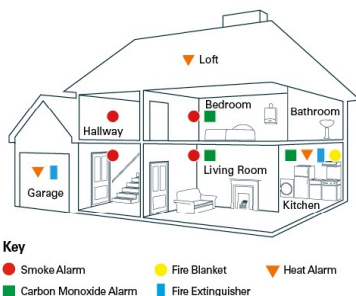
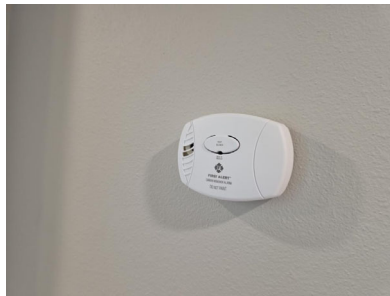
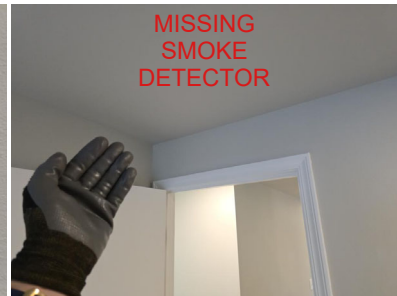
- ☐☐☒☐ **Smoke & Carbon Detectors: Missing In Some Locations: (MISSING DETECTORS)** Smoke and/or CO detectors were missing from one or more areas where they are now required by present day industry standards. We recommend installing proper smoke detectors in all locations as and where required by present standards and local custom.  
(TESTING) We recommend testing the detectors monthly and replacing them with fresh batteries every six months to one year to ensure proper operation and reliability in an emergency.  
(REPLACEMENT) It is recommended that you replace all Smoke and Carbon Monoxide detectors every 5-10 years or per the manufacturer's instructions.

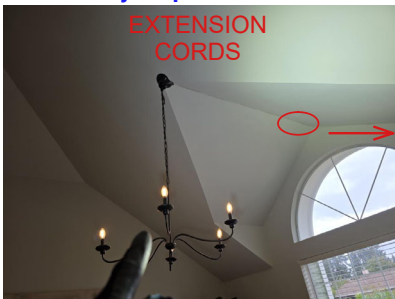
8. ☐ ☐ ☒ ☐ Electrical: 120 VAC & Lighting: (EXTENSION CORDS USED AS PERMANANT WIRING) We recommend removal of all permanently installed extension cord wiring and replacement with appropriate wiring as and where needed by a qualified electrician.

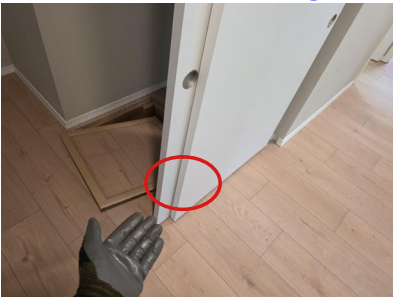
17. ☐☐☒☐ Closet: Double Wide: (DOOR GUIDE HARDWARE: BOTTOM FLOOR GUIDES) We recommend repair, replacement, or installing as needed by a qualified professional to restore proper door operation.

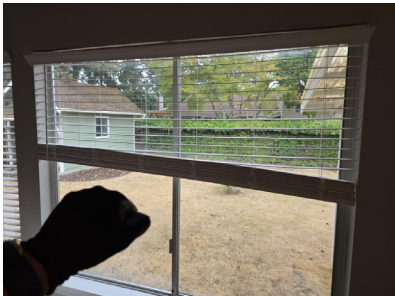
26. ☐ ☐ ☒ ☐ Windows: Aluminum: (TIGHT, NOT EASY TO OPEN/CLOSE) Recommend further evaluation and repair, adjustment, or replacement as needed by a qualified professional to restore smooth operation to the window.

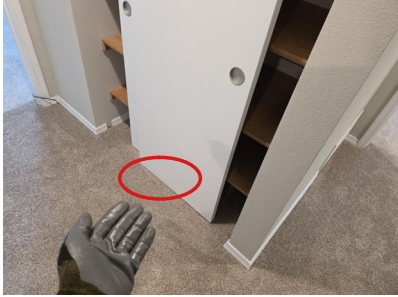
29. ☐☐☒☐ Closet: Double Wide: (DOOR GUIDE HARDWARE: BOTTOM FLOOR GUIDES) We recommend repair, replacement, or installing as needed by a qualified professional to restore proper door operation.

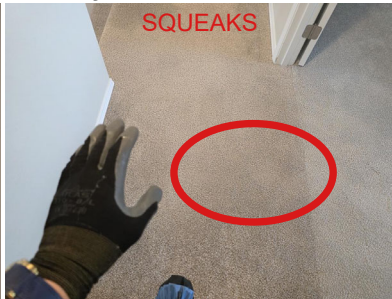
32. ☒☐☐☐ Floor: Carpet: (FLOOR SQUEAKS & DEFLECTION: NOT INDICATIVE OF STRUCTURAL WEAKNESS) In most cases these can be eliminated with additional mechanical fastening (screwing) of the subfloor to the floor joists. The repairs are easily performed in conjunction with floor covering replacement.

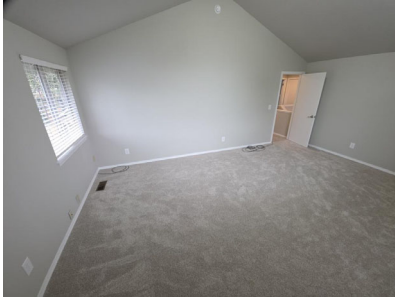
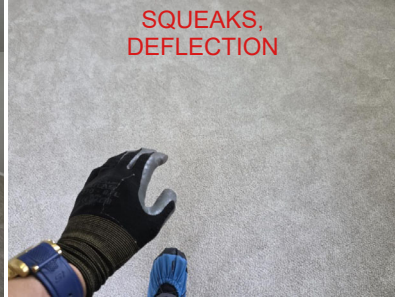
37. ☒ ☐ ☐ ☐ Floor: Carpet: (FLOOR SQUEAKS & DEFLECTION: NOT INDICATIVE OF STRUCTURAL WEAKNESS) In most cases these can be eliminated with additional mechanical fastening (screwing) of the subfloor to the floor joists. The repairs are easily performed in conjunction with floor covering replacement.

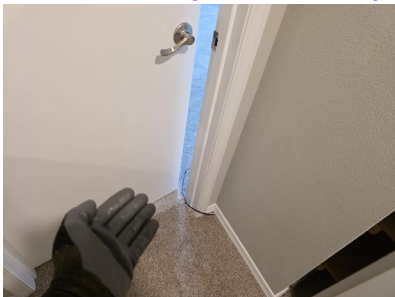
38. ☐ ☐ ☒ ☐ Doors: Wood: (RF CABLES RUN THROUGH DOOR FRAME) Recommend rerouting these as needed to restore full functionality to the door by a qualified professional.

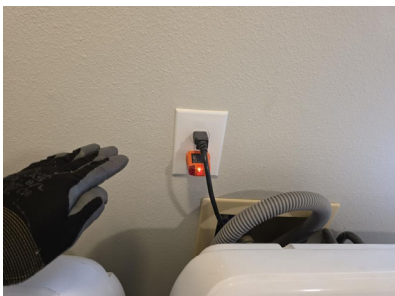
6. ☐ ☐ ☒ ☐ Electrical: 120 VAC & Lighting Circuits: (NO GFCI PROTECTION) Recommend GFCI protection be installed for this area for an increased margin of safety by a competent, licensed electrician.

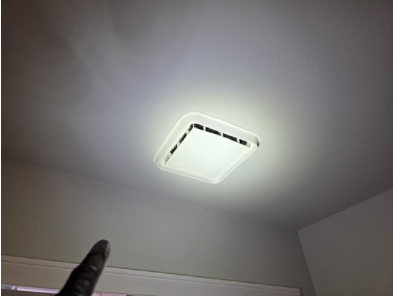
8. ☐☐☒☐ Ventilation: Electric ventilation fan: (FAN IS DIRTY) We recommend cleaning the fan regularly for better operation.

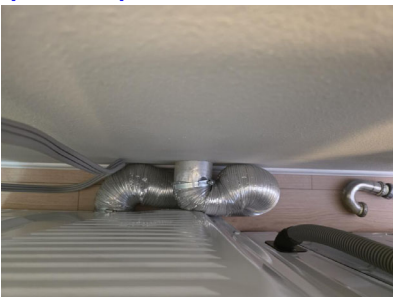
11. ☐☐☒☐ Dryer Vent: Metal flex: (IMPROPER DRYER EXHAUST DUCT MATERIAL: CORRUGATED, TOO MANY BENDS, TRAPS LINT) Recommend replacement with an approved 4-inch smooth-walled rigid metal ducting by a qualified professional.

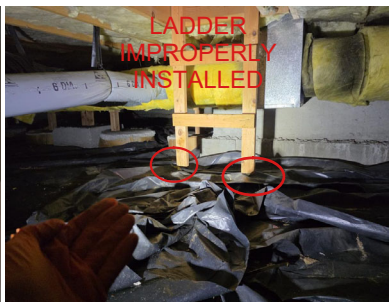
3. ☐☐☒☐ Access: Wood door: (RECOMMEND ADDING A HANDLE FOR EASY ACCESS) The access door is sealed with flimsy trim and is missing insulation underneath. Recommend installing a handle and insulating so as to not damage the trim ends.  
(LADDER IMPROPERLY INSTALLED: FALL HAZARD) Recommend repair or replacement by a qualified professional for safety as needed.

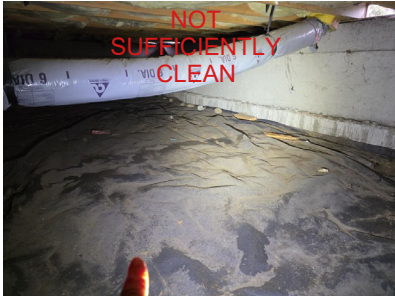
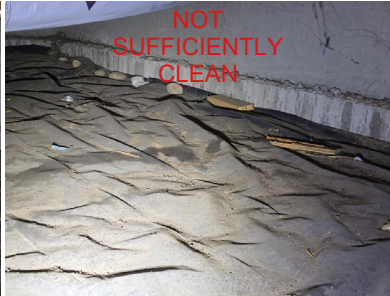
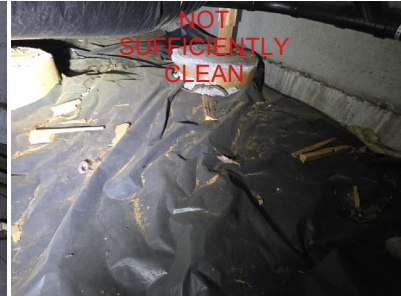
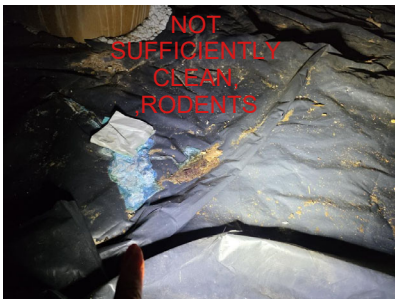
5. ☐☐☒☐ Moisture Barrier: Plastic: (NOT SUFFICIENTLY CLEAN) The vapor barrier was not sufficiently clean in one or more areas and had wood, sawdust, debris, rodent feces & urine. Recommend REMOVAL of all vapor barrier that is covered with saw dust and replacing with new barrier - do not simply cover it up. Excess wood or sawdust present can potentially present conditions that can be conducive for wood destroying organisms (WDO's). Also recommend replacing any parts of the vapor barrier that are not sufficiently clean due to rodent activity (feces & urine). Rodents are attracted by their feces & urine and will always try to return as long as that remains behind.

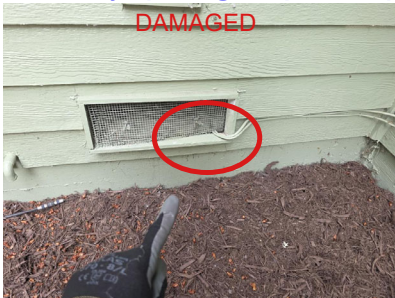
6. ☐☐☒☐ Ventilation: Vents: (DAMAGED SCREENS: GAPS, OPENINGS, CUT FOR CABLE OR PIPING, ETC.) Recommend repair/replacement as and where needed by a qualified professional with screens that completely seal & cover any openings to prevent pest entry.

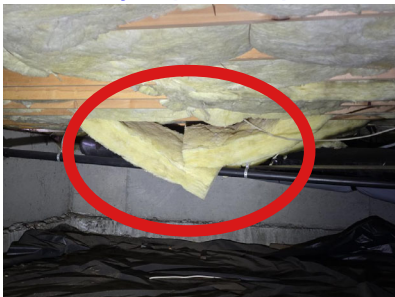
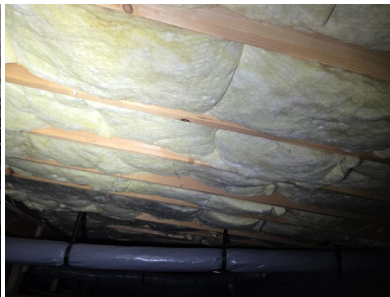
7. ☐☐☒☐ Insulation: Batt: (INSULATION MISSING; PULLED DOWN; FALLING IN SPOTS) Recommend installing any missing insulation, replacing any pulled down insulation and re-installing any fallen insulation as and where needed by a qualified professional.

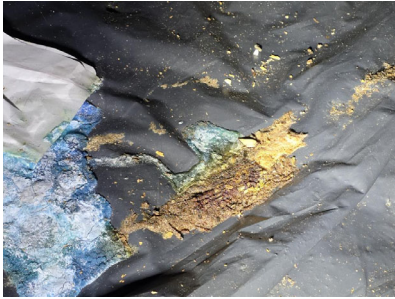
9. ☐☐☒☐ Animal/Rodent Activity: Rodent: (RODENT ACTIVITY) Conditions were observed in the crawlspace indicating evidence of rodent activity. The first step in eliminating rodents from the home is to seal all possible openings. The vapor barrier may also need to be replaced, as any urine, feces, or dead rodents will attract other rodents. We recommend obtaining the advice and services of a COMPETENT & licensed Pest Control Operator.

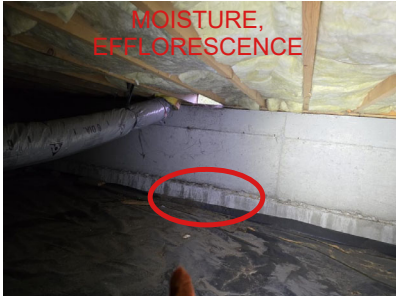
1. ☒☐☐☐ Structure Type: Wood frame
2. ☐☐☒☐ Foundation: Concrete: (MOISTURE ENTRY, EFFLORESCENCE) Signs of moisture entry were noted on the foundation and/or foundation walls. Efflorescence occurs during the winter months when concrete absorbs moisture and the moisture then dries leaving white or chalky deposits on the surface. Recommend improving the grade in the yard where there is a negative slope/grade back towards the foundation; patching and sealing any visible gaps between the foundation and patio, porch, walkway, or driveway; and monitoring as needed when it rains heavily.

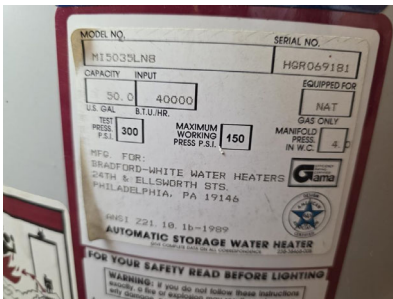
6. ☐☐☒ Water Heater Operation: Functional at time of inspection, Recommend Servicing or Replacement: **(WATER NEEDS ATTENTION)** Some examples of observations noted include: 1) NO SERVICE STICKERS. 2) GAS WATER HEATER IS NOT 18 INCHES HIGH ABOVE FLOOR. 3) MISSING EXPANSION TANK. 4) WATER HEATER IN USE IS PAST STATED DESIGN LIFE, ETC. | **RECOMMENDATION:** Further evaluation and servicing or replacement by a licensed plumber.

**(WATER HEATER OVER 25 YEARS OLD)** The age of the water heater is not a catch-all or direct determinant as to how long it will last, but it is a good gauge as to the remaining life you may have left. Anything over 10-15 years old is considered older by standards and towards the end of its useful and functional life. The water heater appeared to be functional however, we recommend playing it safe and planning on budgeting for a new water heater sometime in the future.

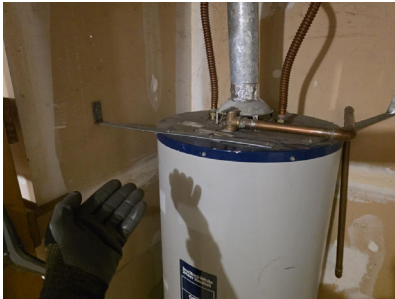
12. ☐ ☐ ☒ ☐ Seismic Strapping: Top Only, Improper Install: **(INADEQUATE TOP STRAP & MISSING LOWER SEISMIC STRAPS: IMPROPER INSTALL)** We recommend a qualified professional properly secure the water heater using approved seismic strapping positioned at the upper and lower thirds of the tank.
